## The Sea versus Wick Breakwater 1863-77 – an instructive disaster

**Roland Paxton** Prof Dr, School of the Built Environment Heriot-Watt University  
Vice-chairman ICE Panel for Historical Engineering Works

In this paper the project and its sea damage failure mechanisms are identified from unpublished and other primary sources and reviewed in an historical engineering context. Repeated damage led to the loss of nearly one-third of the length of the breakwater in 1870, with abandonment following destruction of its 2642 t composite replacement end in 1877.

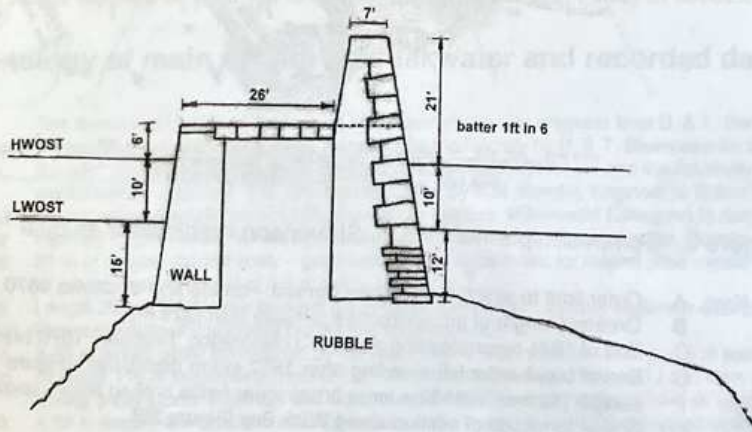
Figure 5. D. & T. Stevenson 1862 cross-section 268 m from shore (1862)<sup>6</sup>  
 NB Tidal range (m) 1984-9: HAT 0.0; MLWS +0.7; MLWN +1.4; MSL +2.0; MHWN +2.8; MHWS +3.5<sup>7</sup>

As the work progressed out into the bay, because of uncertainty about the depth of any scour effect of wave action, D. & T. Stevenson positioned the top of the rubble on which the walls were founded 5.5 m below low water, 50% deeper than the then accepted norm [Figure 5] adopted by Sir John Rennie, the Rendels and others.<sup>8</sup> This practice diminished the thickness of the rubble base to 3.7 m [Figure 6]. At 5.5 m below low water the rubble base seems to have been largely undisturbed by the various storms until probably that of 1877, but this may not have been the case if the structure above had not been swept away. By 1868 the breakwater masonry had been widened by 1.7 m to about 16.3 m. The traditional design adopted with its 4.6 m high parapet [Figures 5&6] was soon to prove inappropriate against the exceptional sea conditions it encountered beyond a point about 150 m from the shore.

The failures are attributable to the inadequacy of the traditional design used. Wave effects during east and south-easterly storms were exacerbated by the long fetch, Pentland Firth currents, the bay's funnel layout and the breakwater's height and line on the 5-fathom bed contour nearly parallel to the waves. If the breakwater had been of uniform construction throughout down to the sea bed its resistance to wave pressure would have been significantly greater.

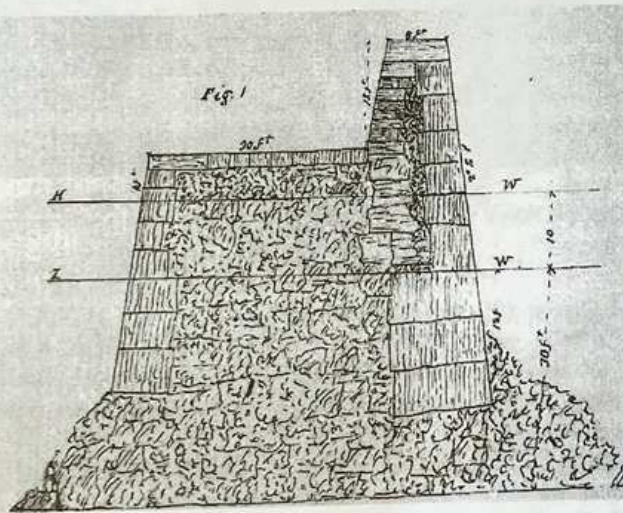
Figure 6. Cross-section as built by 1868 [at 'D' on Figure 3] (Doull 1870)<sup>10</sup>

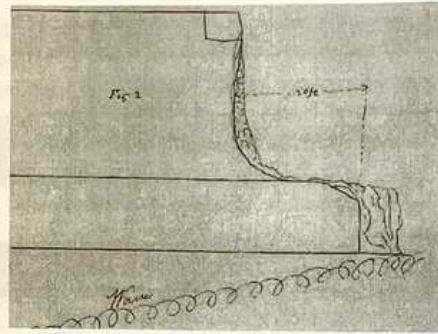
Doull continued, "Figure 2 [Figure 11] is a plan of the outer end of the work as left by the storm. The quay wall being cut away 20 ft [6 m] farther than the outer wall topped by the parapet bears out the (above) remarks . . . greatly accelerated by the heavy timbers of the staging which were built into the quay wall . . . acting as powerful levers in carrying away the front of the roadway leaving the hearting unprotected. When a wave struck heavily against the outer angle of the wall, the water rose about 20 ft [8 m] high and the portion kept ran backward along the face of the wall and increasing in height as the wave [in Figure 11] fed up to the wall. Frequently, when this wave reached the wall and came into collision with the wave running at right angles [about 75°] to it, a considerable body of water was projected to a height of about 60 ft [18 m]. This did not appear to affect the outer wall to any extent. But the earliest symptom of destruction was effected by the mass of water projected over the wall and carrying away considerable portions of the staging and of the front of the quay wall, thus leaving the hearting exposed to every successive downfall of an immense body of water from a great height . . . the first breach was at or near the spot where the staging was carried away . . . about the centre of the work destroyed [116 m in length] . . . the rubble base 18 ft [5.5 m] below low water is said not to have been much disturbed."<sup>10</sup>

Figure 11. End after February 1870 storm - wave line 12° from face [Doull]<sup>10</sup>  
 Waves at other times parallel to face but curved in plan to 5°-9° at landward end<sup>8</sup>

The major breach in 1870 was caused by storm driven waves over a long fetch striking the breakwater at about  $12^\circ$  from its horizontal line. This action set up a secondary wave which in travelling shore-wards clashed with an incoming primary wave about 200 m from the shore forcing water up to a considerable height which, in falling, breached the traditionally designed several-element breakwater (Fig. 5).

The D. & T. Stevenson response to this failure was to modify the breakwater length to just over half that planned and rebuild a 55 m length without parapet with a novel monolithic end. John Hawkshaw and the firm reported jointly to the Fishery Society on remedial work.<sup>18</sup> In an attempt at more homogeneous construction this end comprised 3 courses of 80-100 t blocks deposited in a shallow trench in the rubble surmounted with in-situ mass of rubble concrete measuring about 7.9 x 13.7 x 3.4 m thick, weighing more than 800 t. This was secured to the foundation blocks by 90 mm diameter iron rods, passing through holes in 3 intervening courses of flagstone - a combined mass of 1372 t [Figures 12 & 13]. The new end was achieved but the sea was soon to exploit planes of bond weakness at the back and below.

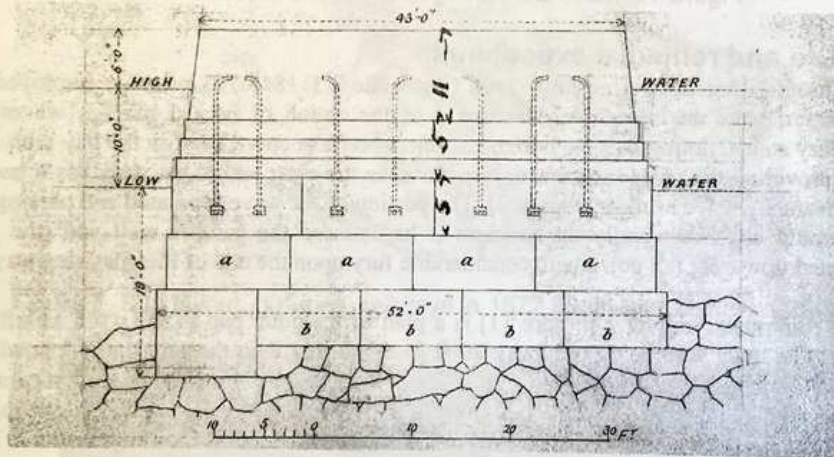
Figure 12. Original drawing of end elevation 1870-72 [Stevenson]<sup>19</sup>.  
 [a - concrete blocks removed by sea. b - not moved by sea]

In December 1872 the 1372 t end block and 46 m of adjoining breakwater were swept away by the sea [Figure 16]. This work was replaced in 1873, with the bolts extended to course 'b' [Figure 12], the whole end now weighing 2642 t. In a January 1877 storm this replacement too was displaced and broken into two pieces, followed by destruction of the adjoining length including the stepped parapet end. It was not until July that the sea was sufficiently calm for divers to do a thorough inspection after which the project was formally abandoned.<sup>13</sup>

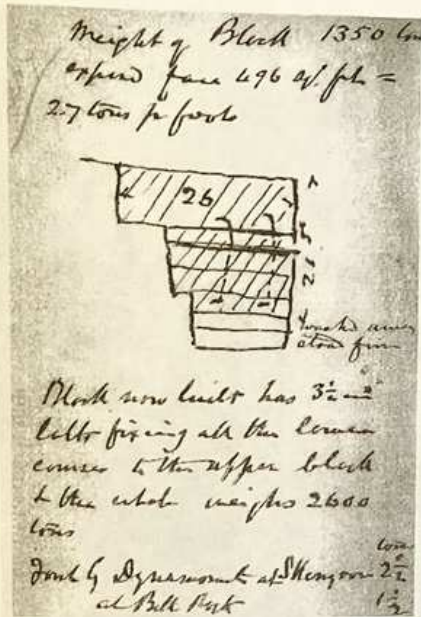
Figure 13. Longitudinal section 1870-72 end [Stevenson]<sup>19</sup> [Plan area about 120 m<sup>2</sup>]

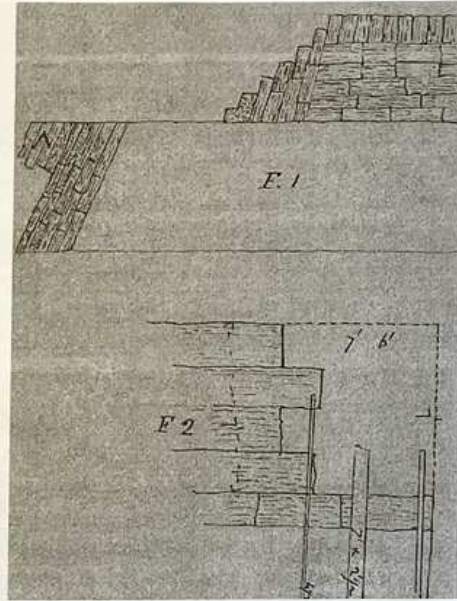
Figure 15. October 1870 end [Doull]<sup>10</sup> [the main bar bent upwards was 178 x 64 mm]

Doull's sketch [Figure 15] shows the new stepped parapet end standing firm and four courses held by the ironwork at 'A' after an October storm. His plan below F2 shows the torn off corner of the breakwater exposed to the full force of the waves. He noted that "the fractured ends are bent up proving that the blow was upwards". The destruction of the parapet was "prevented by its sloping end which deflected the waves and it is probable that had the end of the work been sloped in a similar manner it would have resisted the violence of the storm".<sup>10</sup>

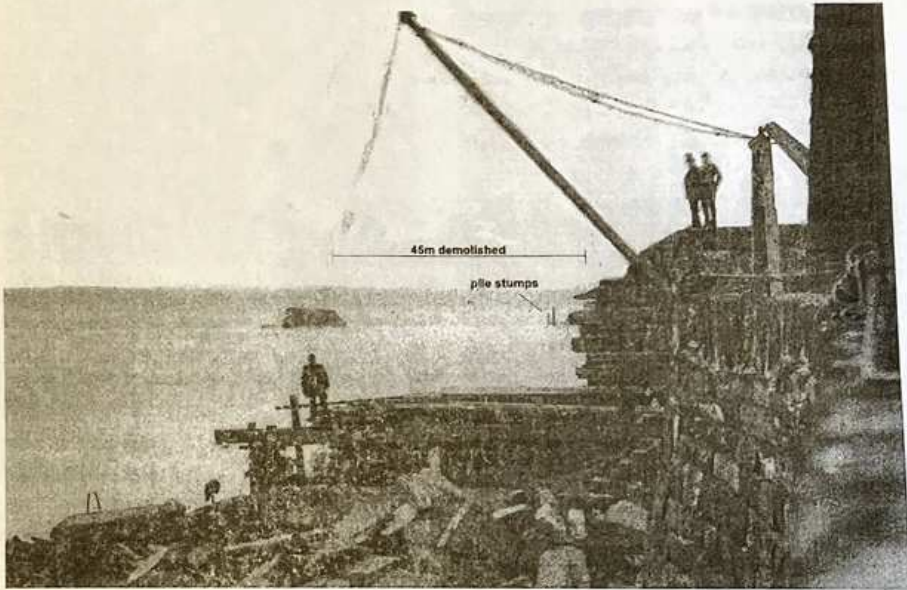
Figure 16. Detached end from North Pier Spring 1873? ©The Wick Society<sup>17</sup>

about 290 kNm<sup>2</sup> slewed and removed the 1372 t end pivoting it about the northwest corner of the stub. In 1877 the pressure carrying away its 2642 t replacement was about 340 kNm<sup>2</sup>. Horizontal resistances were about 110 and 200 kNm<sup>2</sup> respectively.

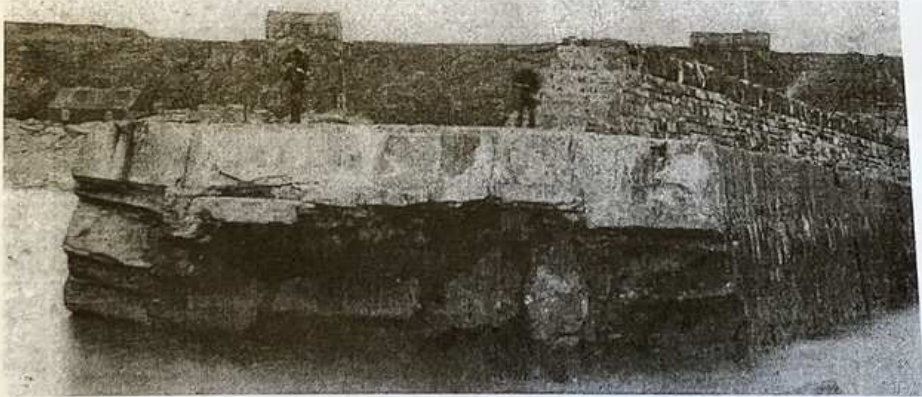
Figure 17. Stump end after December 1872 storm ©The Wick Society<sup>17</sup>

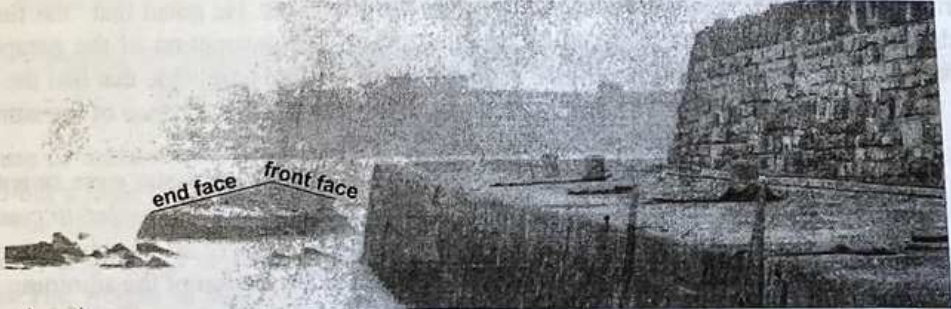
Figure 18. Part of detached end after December 1872 storm. ©The Wick Society<sup>17</sup>

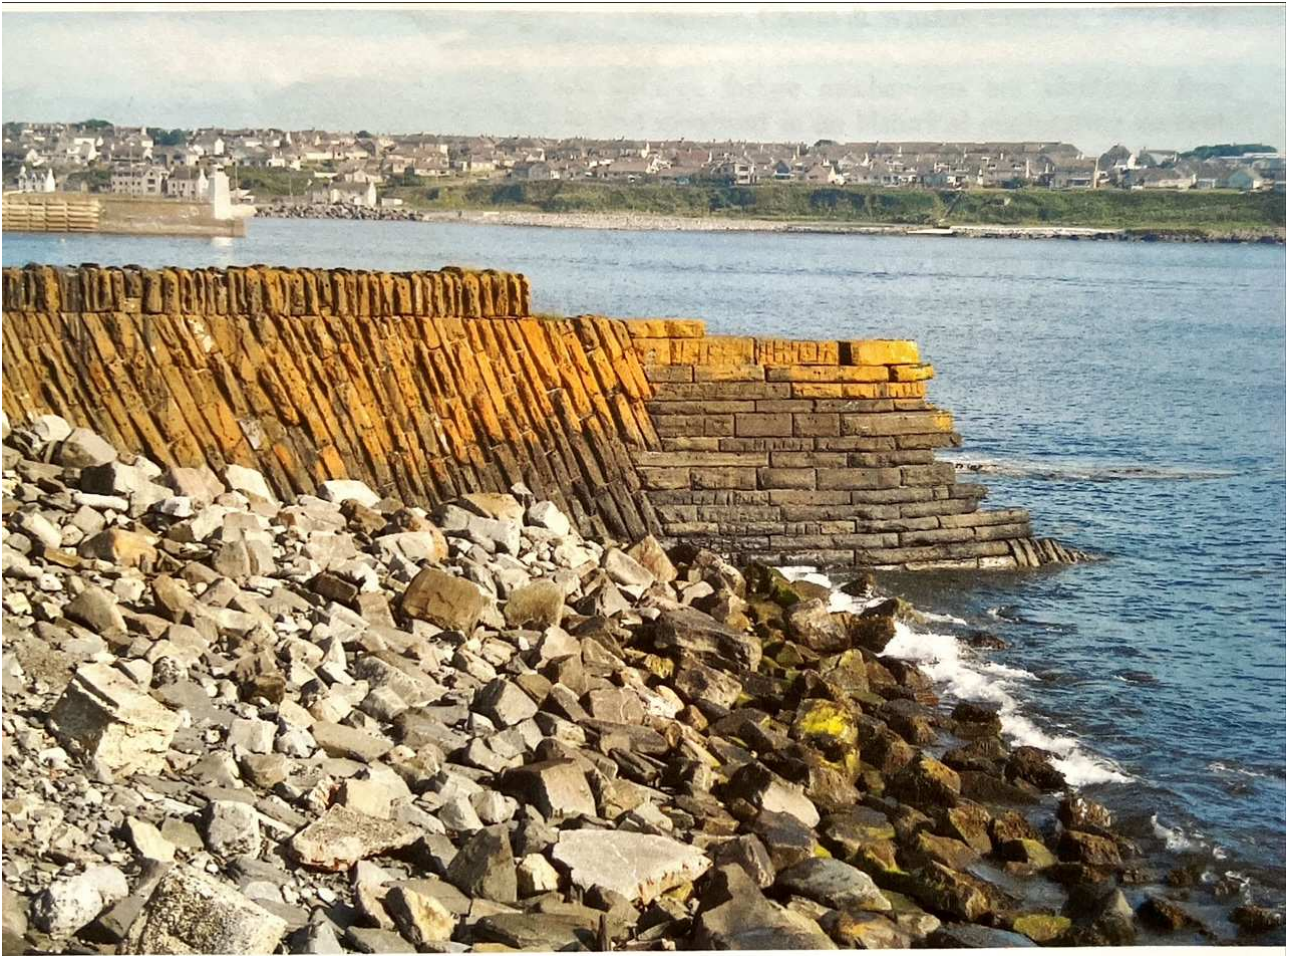
Figure 2c: Present stub of breakwater near low water [July 2009] © Author
