The Sea versus Wick Breakwater 1863-77 – an instructive disaster

Roland Paxton Prof Dr, School of the Built Environment Heriot-Watt University
Vice-chairman ICE Panel for Historical Engineering Works

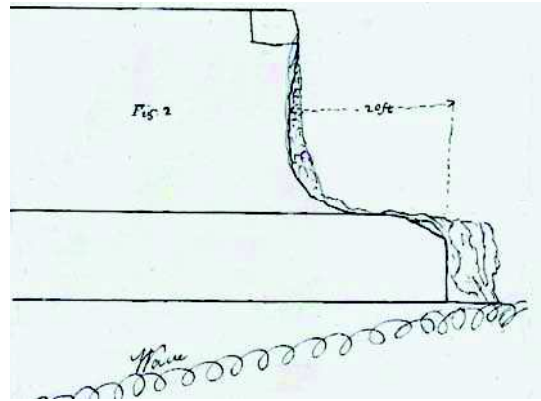
Doull continued, “Figure 2 [Figure 11] is a plan of the outer end of the work as left by the storm. The quay wall being cut away 20 ft [6 m] farther than the outer wall topped by the parapet bears out the (above) remarks . . . greatly accelerated by the heavy timbers of the staging which were built into the quay wall . . . acting as powerful levers in carrying away the front of the roadway leaving the hearting unprotected. When a wave struck heavily against the outer angle of the wall, the water rose about 20 ft [8 m] high and the portion kept ran backward along the face of the wall and increasing in height as the wave [in Figure 11] fed up to the wall. Frequently, when this wave reached the wall and came into collision with the wave running at right angles [about 75°] to it, a considerable body of water was projected to a height of about 60 ft [18 m]. This did not appear to affect the outer wall to any extent. But the earliest symptom of destruction was effected by the mass of water projected over the wall and carrying away considerable portions of the staging and of the front of the quay wall, thus leaving the hearting exposed to every successive downfall of an immense body of water from a great height . . . the first breach was at or near the spot where the staging was carried away . . . about the centre of the work destroyed [116 m in length] . . . the rubble base 18 ft [5.5 m] below low water is said not to have been much disturbed.”¹⁰

Figure 11. End after February 1870 storm - wave line 12° from face [Doull]¹⁰
 Waves at other times parallel to face but curved in plan to 5°-9° at landward end⁸

The D. & T. Stevenson response to this failure was to modify the breakwater length to just over half that planned and rebuild a 55 m length without parapet with a novel monolithic end. John Hawkshaw and the firm reported jointly to the Fishery Society on remedial work.¹⁸ In an attempt at more homogeneous construction this end comprised 3 courses of 80-100 t blocks deposited in a shallow trench in the rubble surmounted with in-situ mass of rubble concrete measuring about 7.9 x 13.7 x 3.4 m thick, weighing more than 800 t. This was secured to the foundation blocks by 90 mm diameter iron rods, passing through holes in 3 intervening courses of flagstone - a combined mass of 1372 t [Figures 12 & 13]. The new end was achieved but the sea was soon to exploit planes of bond weakness at the back and below.

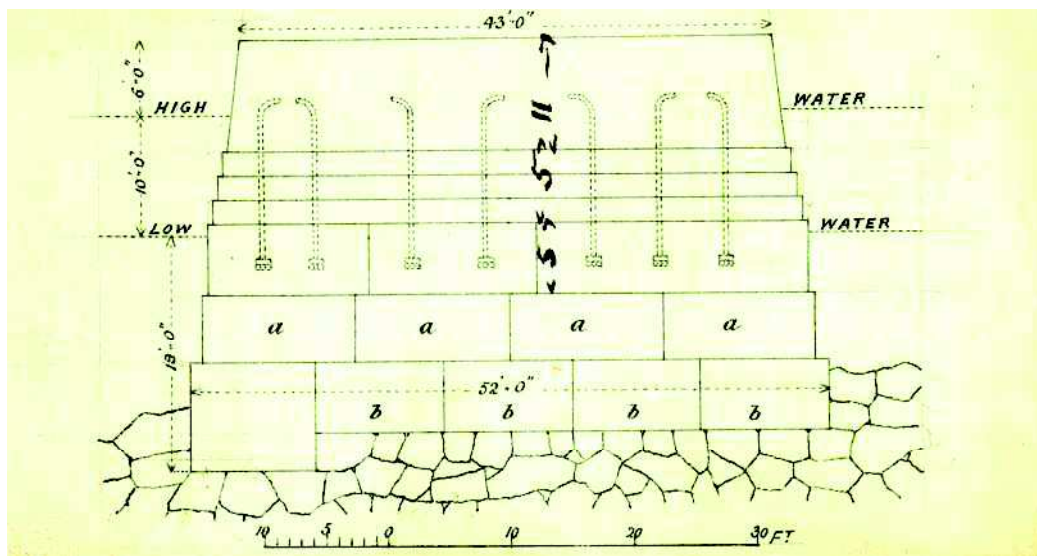
Figure 12. Original drawing of end elevation 1870-72 [Stevenson]¹⁹.
 [a - concrete blocks removed by sea. b - not moved by sea]

bond between each end and existing masonry which, combined with a weak horizontal plane [Figure 12 – on top of ‘a’ in 1872; on top of rubble in 1877], enabled displacement to occur from, probably scour, uplift and horizontal pressure. In the 1872 event this force was about 290 kNm² [Figure 13] overcoming a horizontal resistance of 110 kNm² to slew the 1372 t end [Figure 12]. Respective forces for the 2642 t (1877) end were 340 and 200 kNm². If founded on the sea bed the resistance of the work would have been much greater. The materials and workmanship were of high quality and, although a failure, the project has proved instructive.

In December 1872 the 1372 t end block and 46 m of adjoining breakwater were swept away by the sea [Figure 16]. This work was replaced in 1873, with the bolts extended to course 'b' [Figure 12], the whole end now weighing 2642 t. In a January 1877 storm this replacement too was displaced and broken into two pieces, followed by destruction of the adjoining length including the stepped parapet end. It was not until July that the sea was sufficiently calm for divers to do a thorough inspection after which the project was formally abandoned.¹³

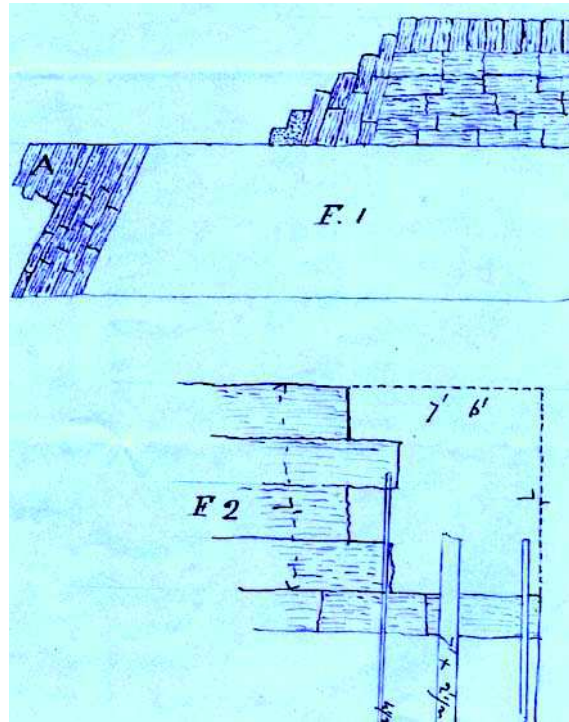
Figure 15. October 1870 end [Doull]¹⁰ [the main bar bent upwards was 178 x 64 mm]

Doull's sketch [Figure 15] shows the new stepped parapet end standing firm and four courses held by the ironwork at 'A' after an October storm. His plan below F2 shows the torn off corner of the breakwater exposed to the full force of the waves. He noted that "the fractured ends are bent up proving that the blow was upwards". The destruction of the parapet was "prevented by its sloping end which deflected the waves and it is probable that had the end of the work been sloped in a similar manner it would have resisted the violence of the storm".¹⁰

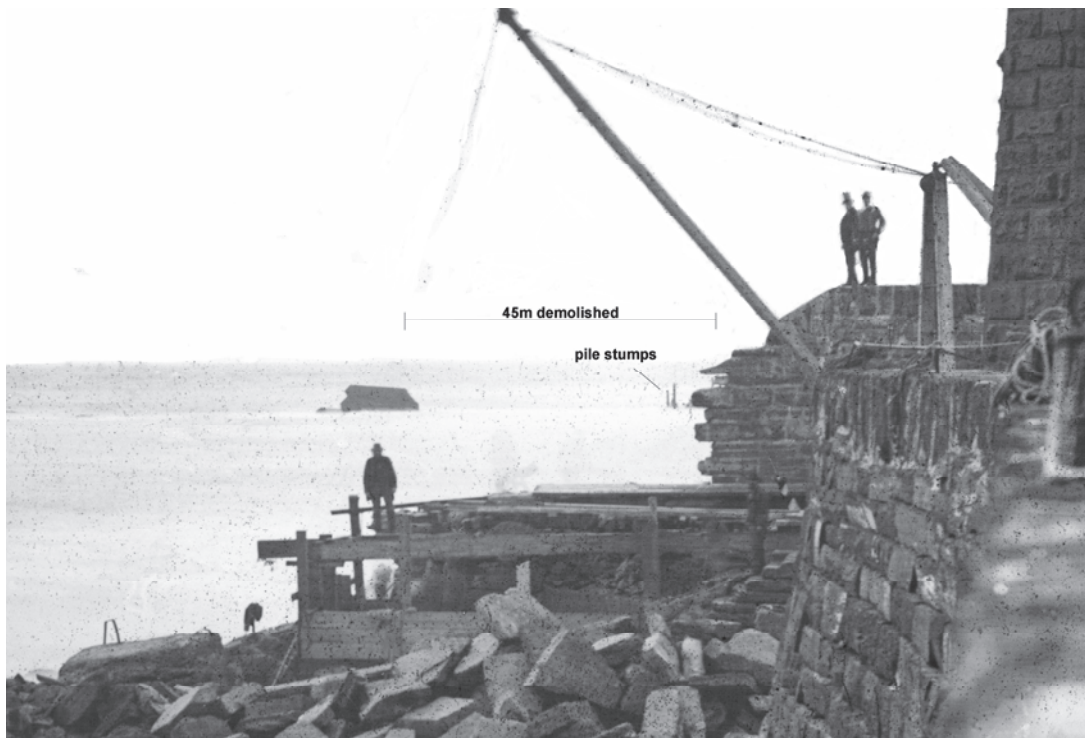
Figure 16. Detached end from North Pier December 1872 ©The Wick Society¹⁷

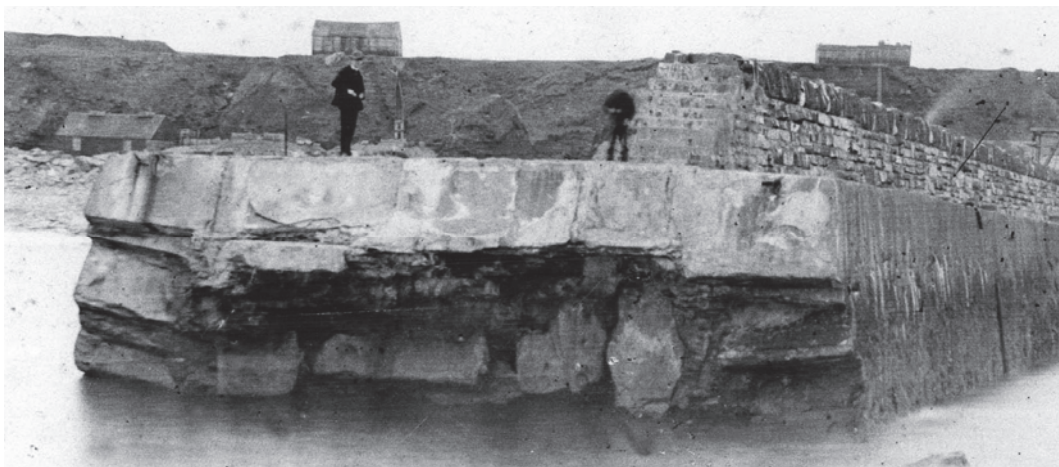
Figure 17. Stump end after December 1872 storm ©The Wick Society¹⁷

Later failures arose from displacement by the sea of the remedial ends which opened up the adjoining work to erosion [Figures 16-19]. Wave impact exploited an inadequate vertical

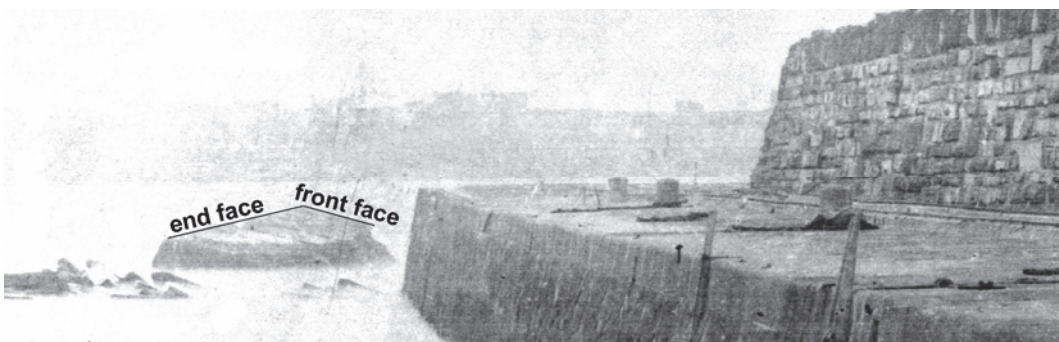
Figure 18. Part of detached end after December 1872 storm. ©The Wick Society¹⁷

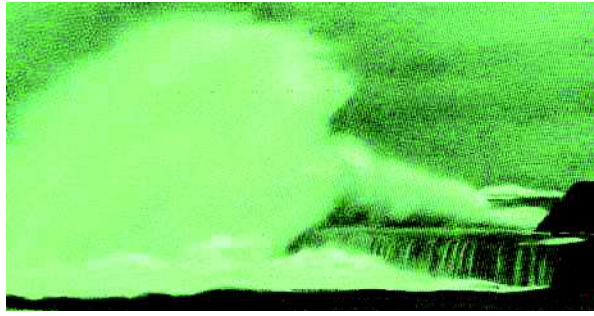
Figure 19. December 1872 as storm waned just above low water - spray 20 m high²⁰

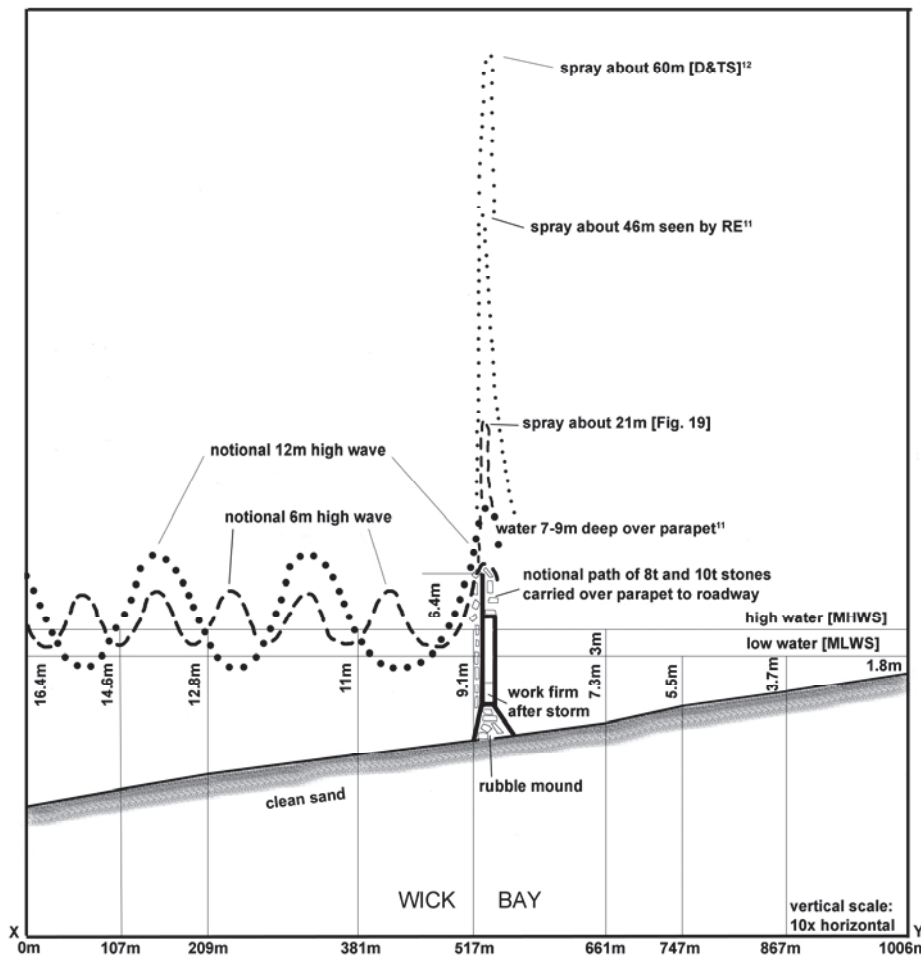
Figure 20. Longitudinal section Wick Bay [X-Y Figure 3] – notional wave action

Two failure mechanisms resulting from the force of the sea in south-easterly storms at Wick have been identified against which the breakwater was swept away despite an impressive remedial effort. The February 1870 failure stemmed from a clash of primary and secondary waves at the breakwater east face about 60 m from its seaward end forcing water up to 18 m in height which, in falling and destroying the hearting and inner wall, breached the work.
