Conservation of Laigh Milton Viaduct, Ayrshire

R. A. Paxton, MBE, MSc, CEng, FICE, FRSE

This paper is about an ICE-initiated project to conserve Laigh Milton viaduct in Scotland, the world's oldest surviving public railway viaduct. Between 1992–96, the project's directors raised £1.065 million, bought the viaduct and completed the necessary work within budget on a design-and-build basis. This paper covers all aspects of the project, from initial fund raising and planning to site investigation by radar scanning and structural refurbishment. It will serve as a useful case study for anyone involved in the increasing number of projects now planned and underway to conserve the world's civil engineering heritage.

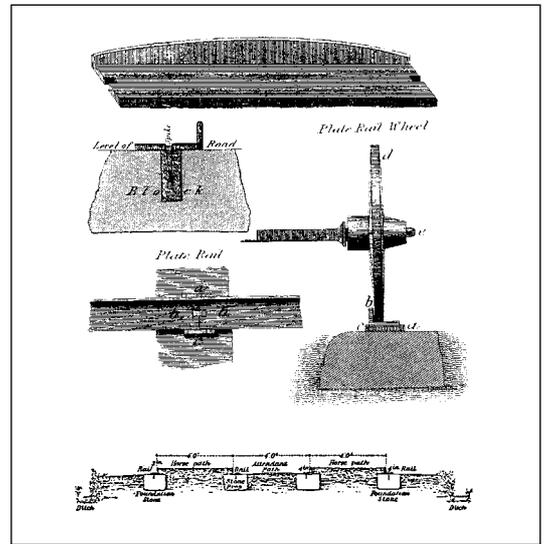
Fig. 4 (above right). Iron plate-rail details

port and connection are indicated in Figs 4 and 5.^{1,10} A rectangular-headed wrought iron spike secured adjoining rails in place. Most of the original rails were made by Glenbuck Iron Company which by 1813 had received £13 345 for about 72 000 rails,⁶ representing nearly one-third of the railway's engineering cost. By 1818 a stronger rail invented by Wilson was in use, with two longitudinal 'feathers' underneath (Fig. 5). Several years later he facilitated replacement rail-laying by introducing an iron saddle under each rail end (Fig. 4).¹ The viaduct, although closed to most operators in July 1846, was still carrying some colliery traffic in November 1846 just before its abandonment. The upgraded, locomotive-traction edge-railway, with larger radii curves, became operational over a timber structure immediately south of the viaduct in spring 1847.

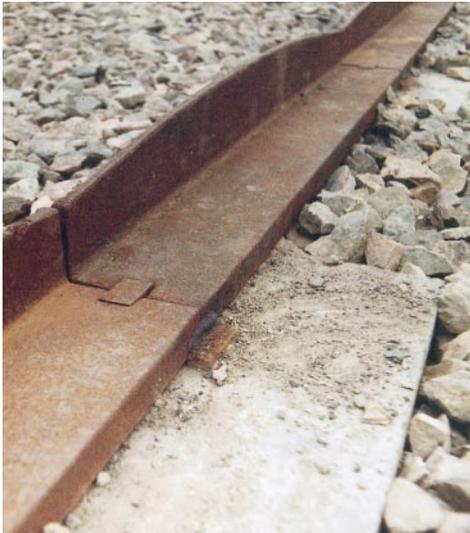
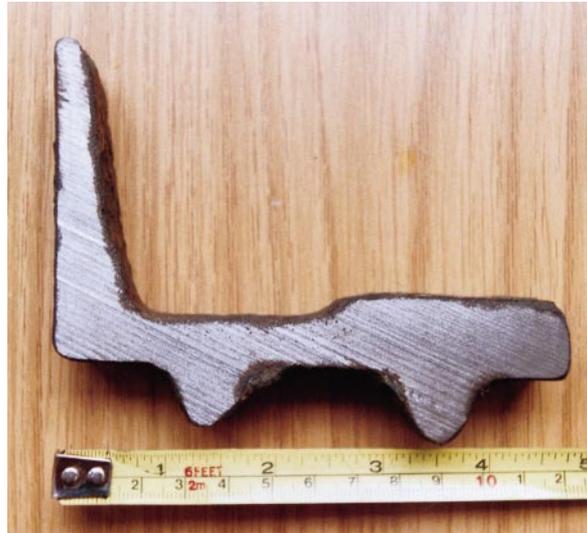
Fig. 5. Worn rail section at mid-length (far left) and replica plate-way detail (left) (now in the ICE museum at Heriot-Watt University)

Several original cast iron rails were found on site during the conservation work, one of which was used to make a pattern for the replica track rails which have been provided as part of the viaduct's refurbishment (Fig. 5). Each rail was 0.91 m (3ft) long with a longitudinally curved upstand on the inside increasing from about 50 mm at each end to 76 mm in the middle. Its form and method of sup-

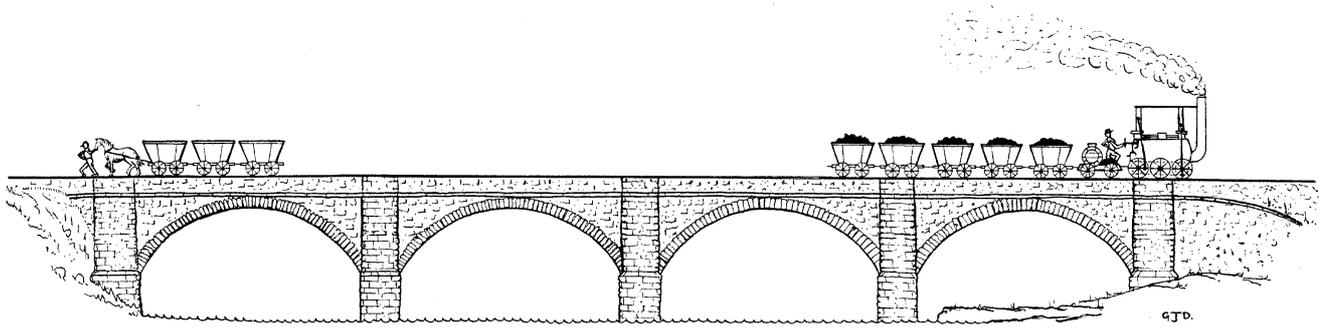
Fig. 6 (below).
Conjectural view of
Milton Bridge in
1816, looking south

About five years after the railway had opened, and nine years before the opening of the Stockton & Darlington railway, the Duke of Portland introduced steam locomotion on the line to haul coal from his collieries (Fig. 6).^{12,13} A trial was conducted using, it is believed, a Stephenson Killingworth type locomotive with six, flat-soled wheels. The engine was appropriately named *The Duke* and, according to an eye-witness,¹⁴ its trial was conducted by Robert Stephenson, George Stephenson's brother. It is understood that the engine 'from its defective construction and ill adaption to the rails drew only 10 tons at the rate of five miles an hour'.³ Buchanan stated that the locomotive 'succeeded well', but was 'given up on account of its destructive effect on the cast iron rails although its weight was only five tons'.¹⁵ Modern-day calculations indicate that a wheel load of 1.7 t would have been sufficient to break a rail in shear near the edge of a block, a finding consistent with broken rails found. This load would have been easily achieved at times with hammer-blow effect and rocking caused by the locomotive's primitive vertical to horizontal load transmission. A study of the railway company's monthly payments to the Kilmarnock Foundry for replacement rails and castings revealed a significant increase in expenditure from September 1816, indicating that the locomotive was probably in use by then (Fig. 7), though its duration on the line is not known.

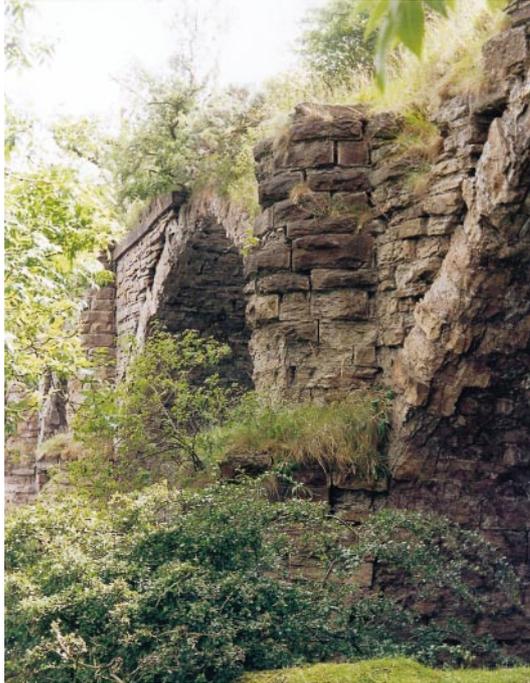
Fig. 8. West end, north face with bulging, stone loss and vegetation

cy by leading engineers. If this had been adopted here instead of clay fill, it would have obviated the spandrel bulging and some of the stone loss that occurred. Much of the viaduct's stone quality and some workmanship at the west end were only just adequate for the purpose (Figs 8 and 9) but the flat-stone, lime-mortar-bedded, pier hearting carried up to 1.5 m above arch springing was an effective feature which had probably saved the piers from collapse (Figs 10 and 11). In cross-section, the spandrels presented an unusual application of the classic gravity retaining wall (Fig. 12). Although a valuable example of early railway construction, the viaduct's outstanding historical significance rests mainly on its important associations and in being the earliest known survivor of a type of multi-span railway structure subsequently adopted universally.

not of the best quality being of a minutely fissured weak texture. With lack of maintenance, vegetation and weather effects, this weakness had led to widespread stone loss and serious undercutting to all piers at or near water level. The west pier was seriously cracked, mainly around its traditional hearting, and had lost about a third of its 2.9 m thickness (Figs 10 and 11). Some movement had occurred long ago causing stretching and hogging of the arches adjoining the west pier. From an unbroken glass tell-tale installed in 1992 it was believed that no further movement had taken place in the three years prior to the start of work. The north spandrel wall had suffered extensive stone loss at the top and some peeling away of pier bull-noses (Fig. 8). Colliery records indicated that the structure had not been undermined by coal extraction.

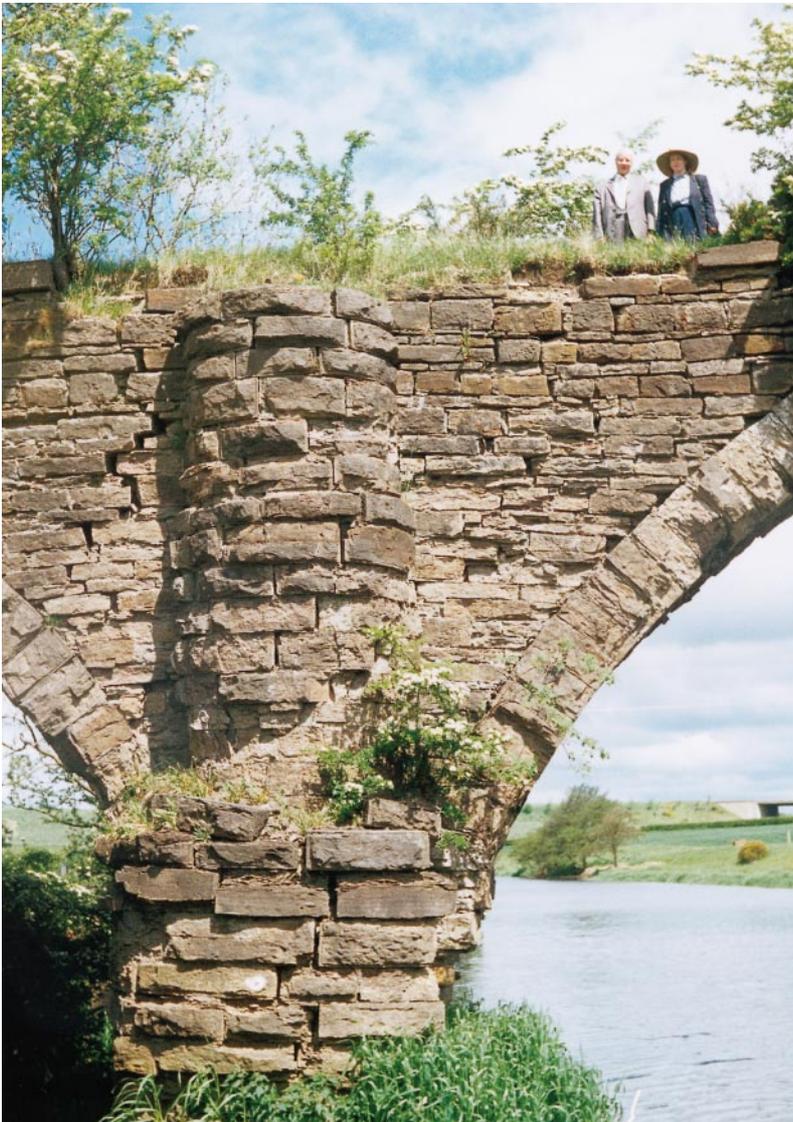
Fig. 9. (below). West pier, south face with cracking and stone loss

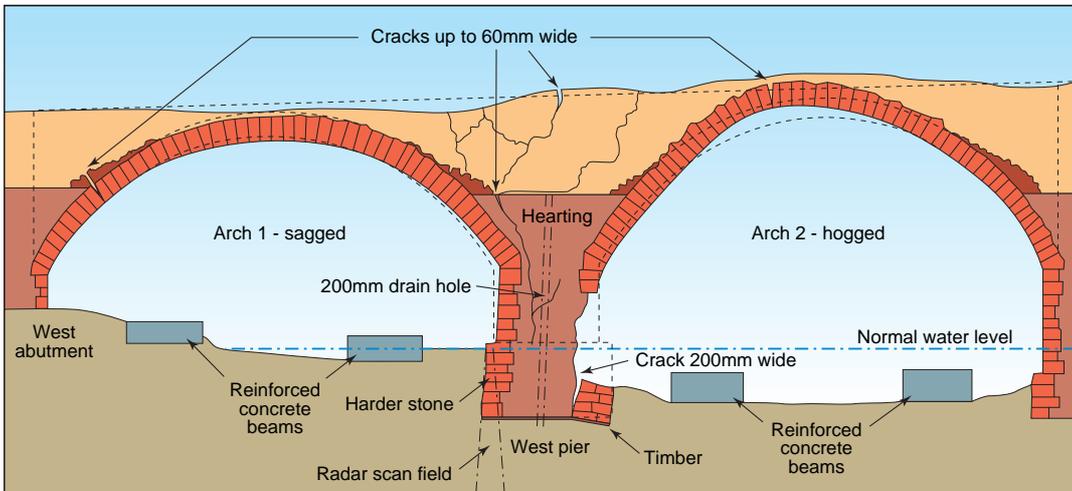
Fig. 10. Section of west pier and adjoining arches with spandrel fill removed—looking north

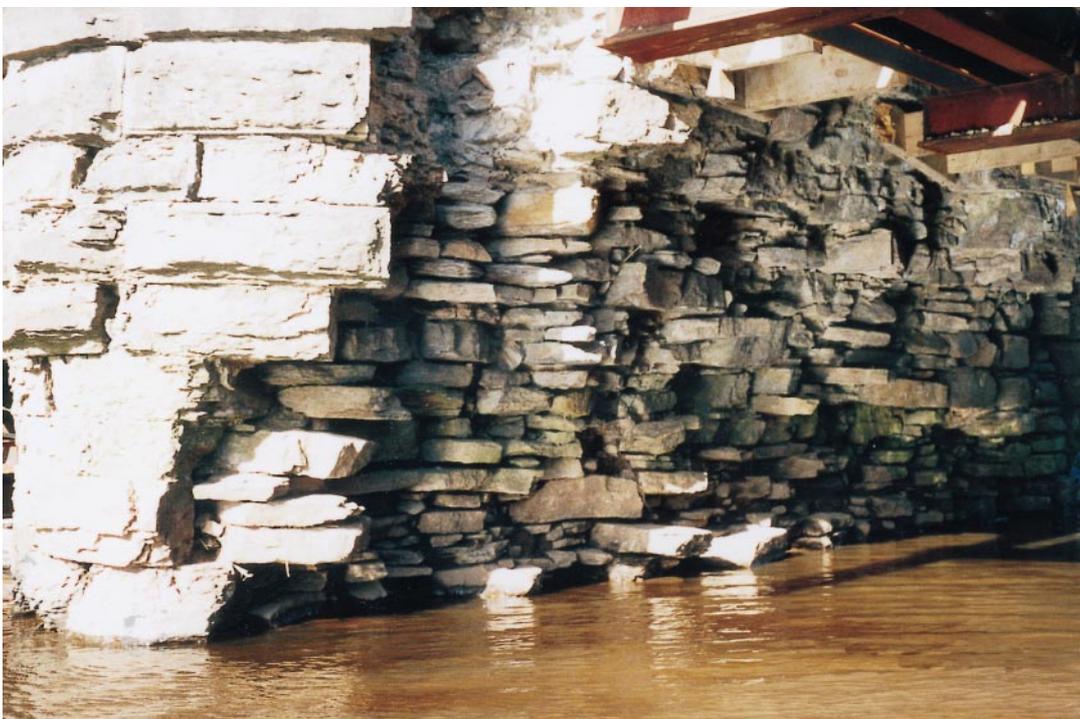
Fig. 11. West pier, east side—erosion into lime-mortar-bedded hearting (courtesy Mr F. M. Jones)

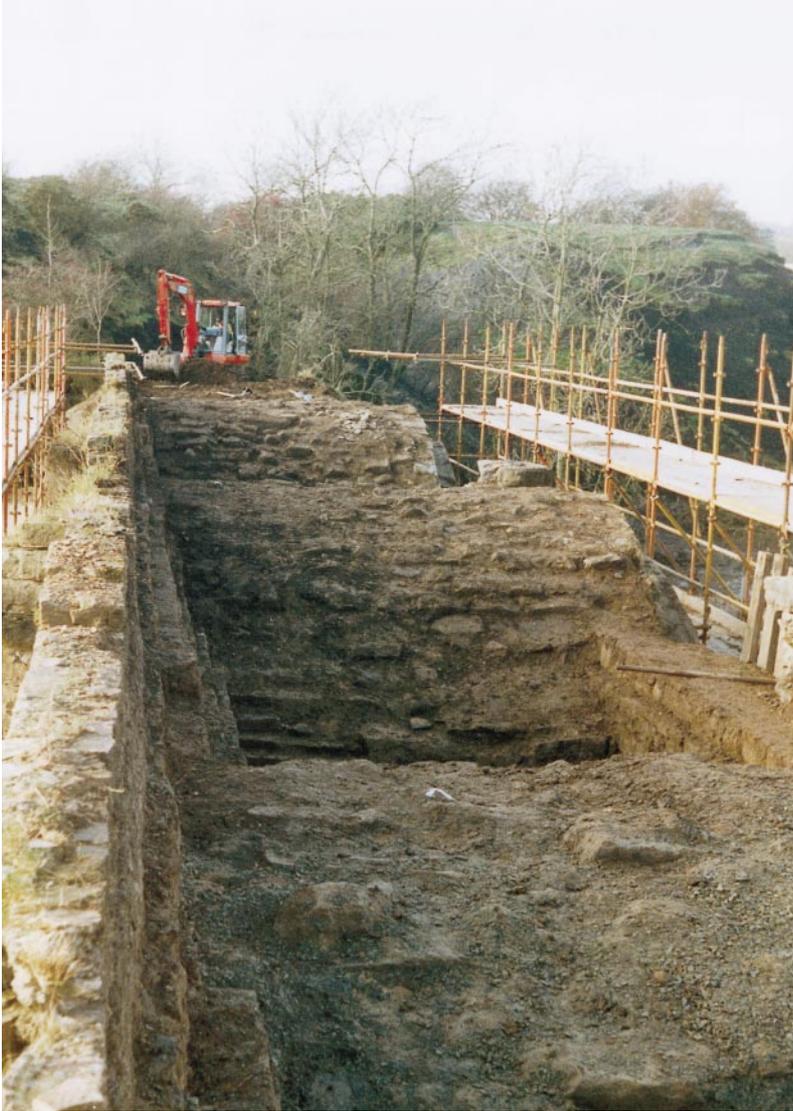
Fig. 12. South span-drel wall and undressed extrados of arches

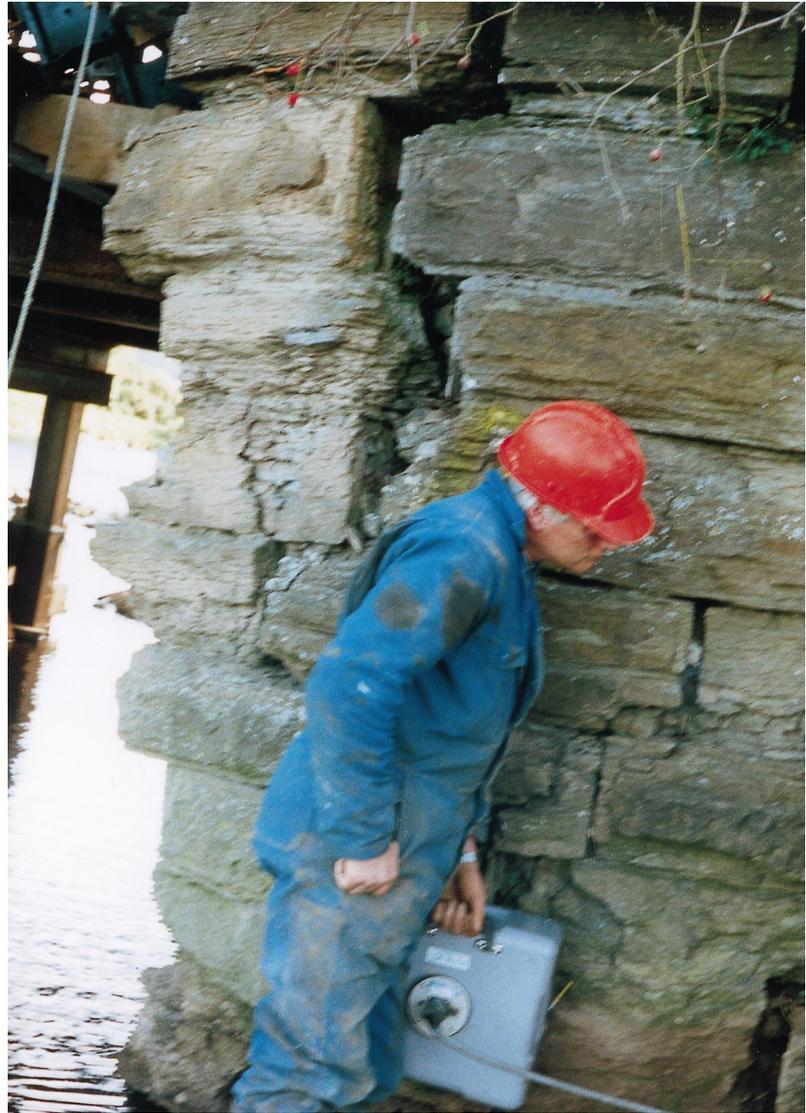
Fig. 13. West pier — radar scanning with Oyo receiver

To provide as much ground information as possible for prospective contractors before tendering, a high-frequency radar scanning contract was let, which basically indicated firm ground conditions under the piers of the viaduct. Later, before the remedial measures to the west pier were finally determined, a vertical scan identified ten dielectric layers. Constants between 4.1–9.3 indicated stone,

above what proved to be a 100 mm thick traditional pier platform of hard saturated wood at 2 m resting on acceptably firm material. Fractures indicated normal to the bedding and passing through both bedrock and structure may have resulted from seismic activity (Figs 13 and 14).

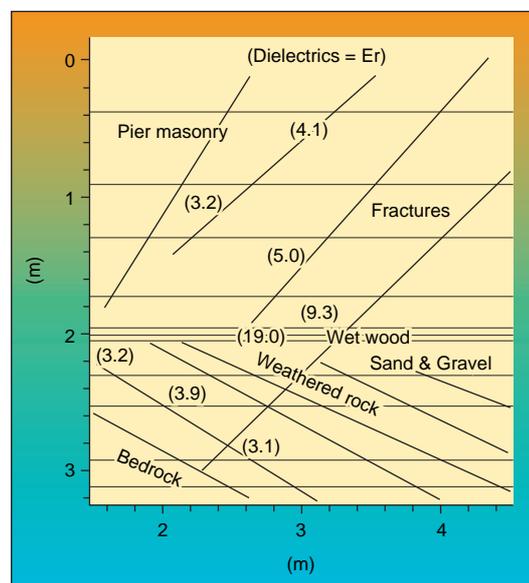
Fig. 14. West pier, west side—vertical radar plot to 3.2 m depth

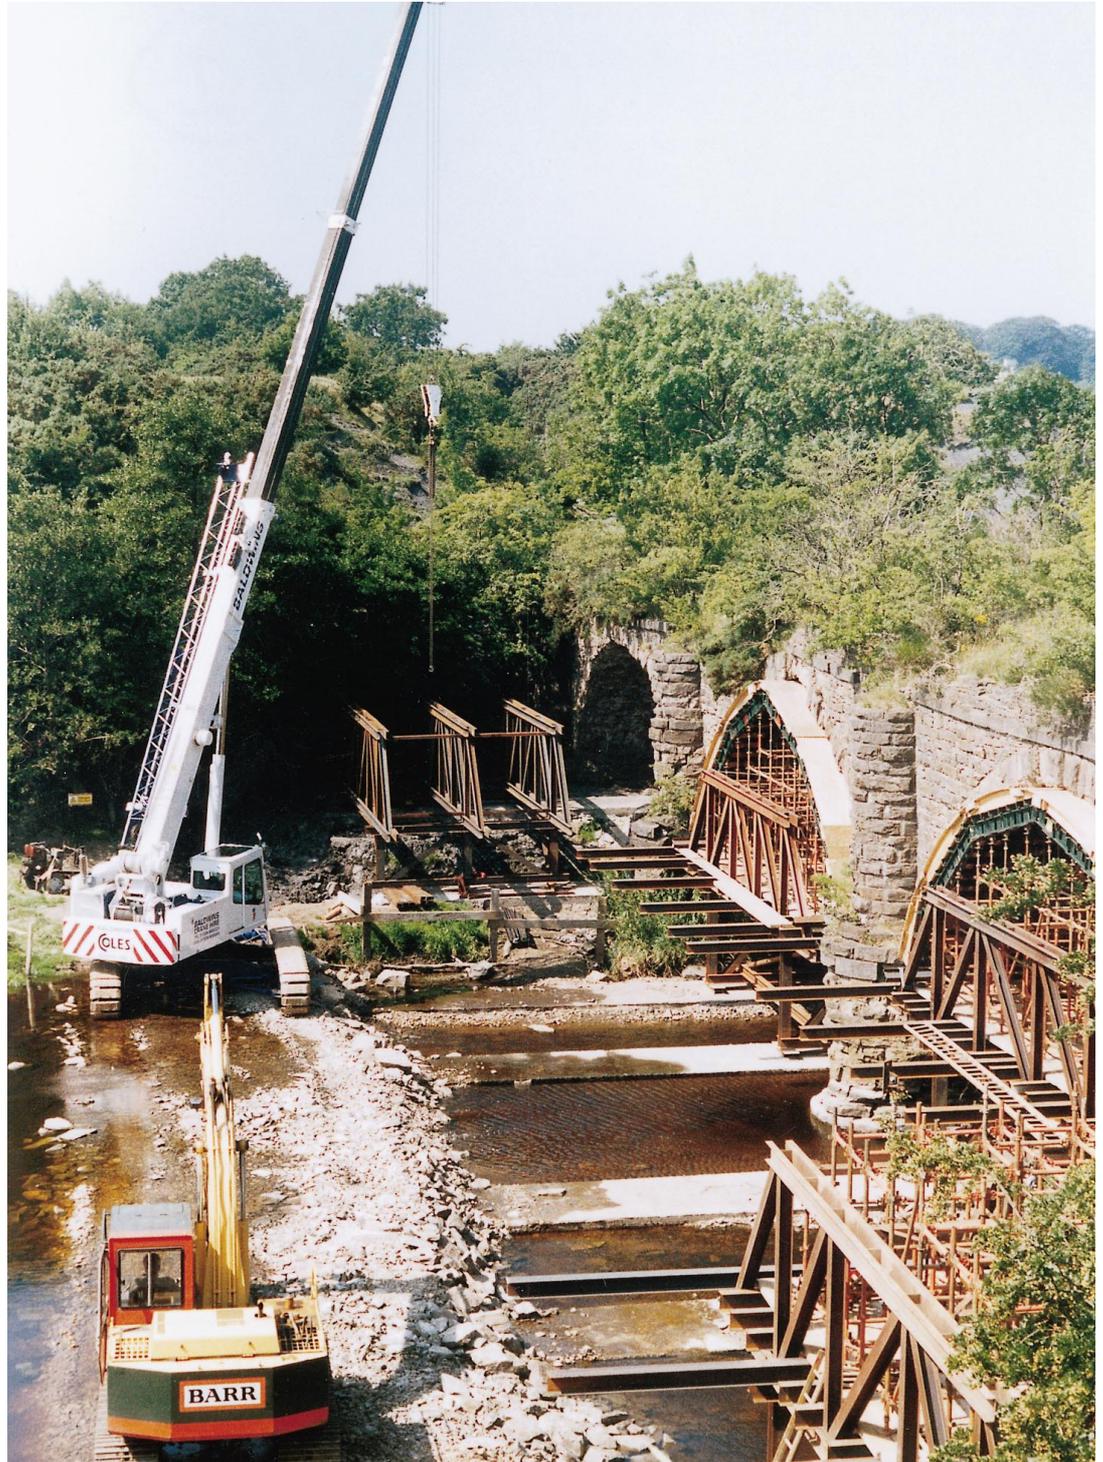
Fig. 15. State of work on 3 August 1995 with water lowered at viaduct

Work to the contractor's approved design started on site in June 1995. In August the water level had been lowered by nearly 1 m at the viaduct by creating a temporary rubble dam immediately upstream (Fig. 15), and temporarily diverting the river through the fish farm downstream and so bypassing the mill-dam (Fig. 1). This measure enabled plant and workmen to cross the river at the site independently of the viaduct and pairs of transverse reinforced concrete beams to be constructed on the river bed under each arch. Temporary steel support frameworks were then assembled between the dam and the viaduct and slid into place under each arch by means of skates running on the surface of the beams (Figs 15 and 16). Plywood against the intrados of each arch was held in place and supported from the framework by means of adjustable props (Fig. 17). As soon as all the arches were secured, an excavator com-

The undercut piers had been secured by means of reinforced concrete collar surrounds resting on foundation courses of harder stone which, following dewatering and debris removal, were found to be mainly intact (Fig. 15). The surround to the west pier (Fig. 18) was more extensive than to the other piers. The surrounds were faced with matching new stone (Fig. 20). Grouting up the fissures below the head of pier 1 consumed 320 l of cement mortar. Sufficient funding remained to provide 7.3 m of replica plate-way, ductile cast iron plaques with explanatory details of the viaduct and project, and fencing and public access ramps at each side (Figs 21 and 22). The good working relationship which existed between the contractor, engineer's representative and secretary helped to maximize preservation of the original structure and to achieve the best practicable quality of conservation. An indication of the extent to which this was successful can be gained from a comparison of Figs 22 and 8 and 23 and 24. Note the preservation of the 0.3 m distortion of arch 2 (Fig. 10) and that from the approach the light-coloured railings are unobtrusive visually against the sky. The viaduct was formally re-opened on 29 October 1996.

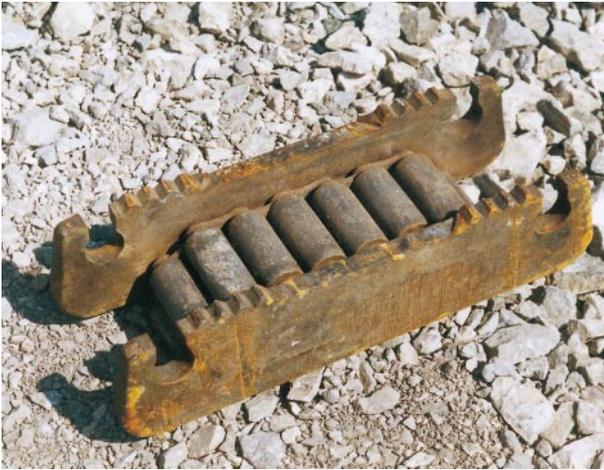
Fig. 16 (above left). Skate used for sliding temporary support frameworks into place

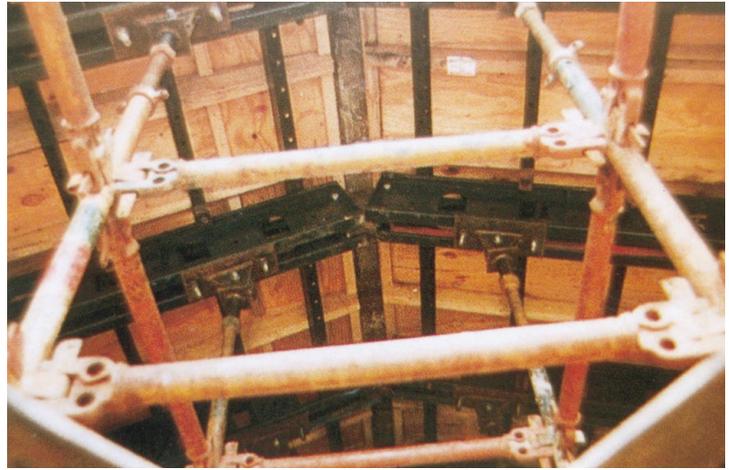
Fig. 17 (above right). Top of support framework from inside

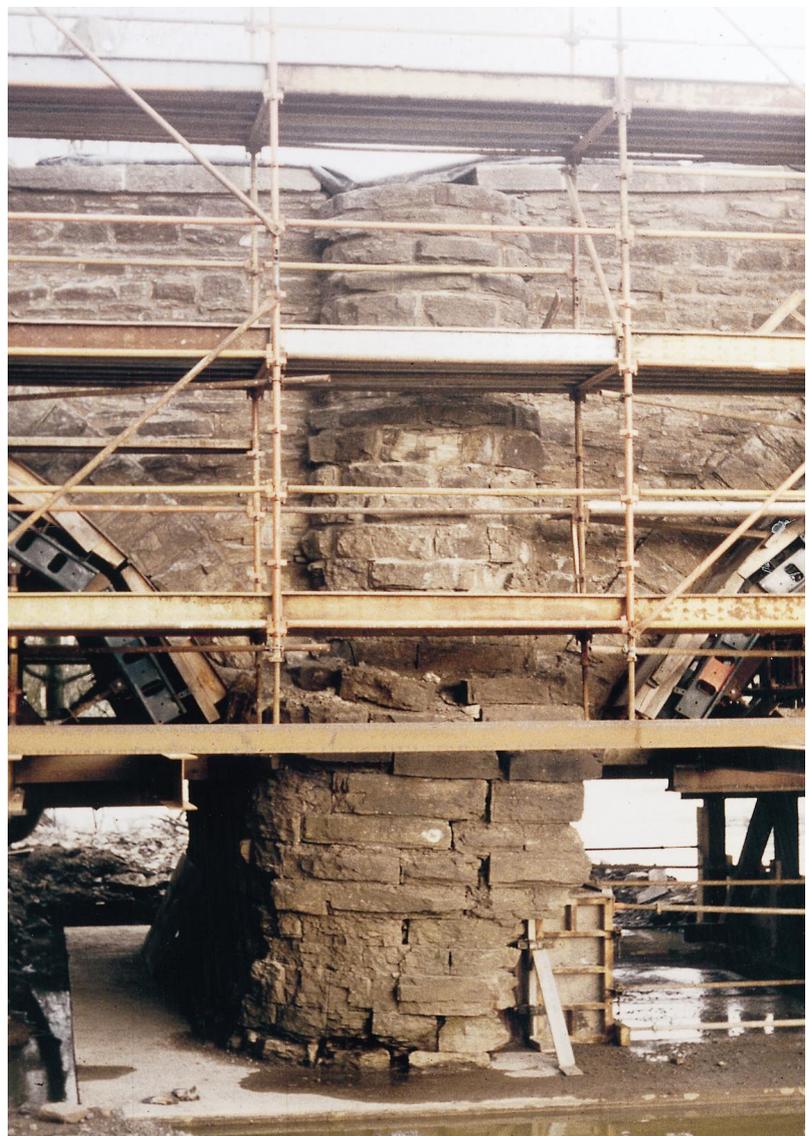
Fig. 18 (below). West pier, west side—pointing and concrete surround to base

By November 1995 the clay fill had been removed from the spandrels and the replacement of missing stones and pointing from scaffolding had begun (Fig. 18). It was considered impracticable, and unnecessary structurally, to try to replace most of the extensive loss from *in situ* stones, but all loose flakes were removed. The site agent had shown initiative by artificially ageing a trial area of new stone with peat and milk to resemble the old stonework, but it was insisted that the new stone should remain untreated in order that old and new work could be identified. The mortar mix for bedding was 1 hydrated lime: 1 cement: 6 sand and, for face pointing, 1 hydraulic lime: 3 sand. By July 1996, the spandrel walls were almost completed, surmounted with new copings and railings, and the cavity infilled with mass concrete to waterproofing level with a longitudinal fall to drains at each side of the viaduct (Fig. 19).

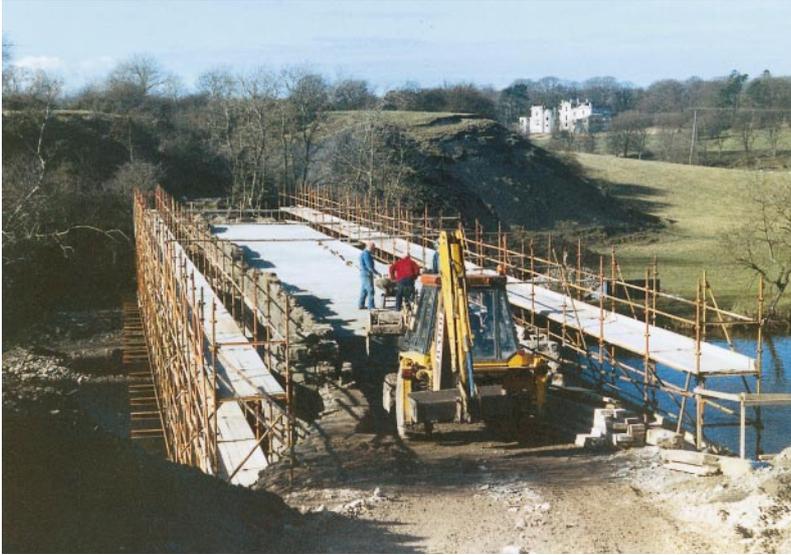
Fig. 19 (top). Non-structural concrete spandrel infill before waterproofing

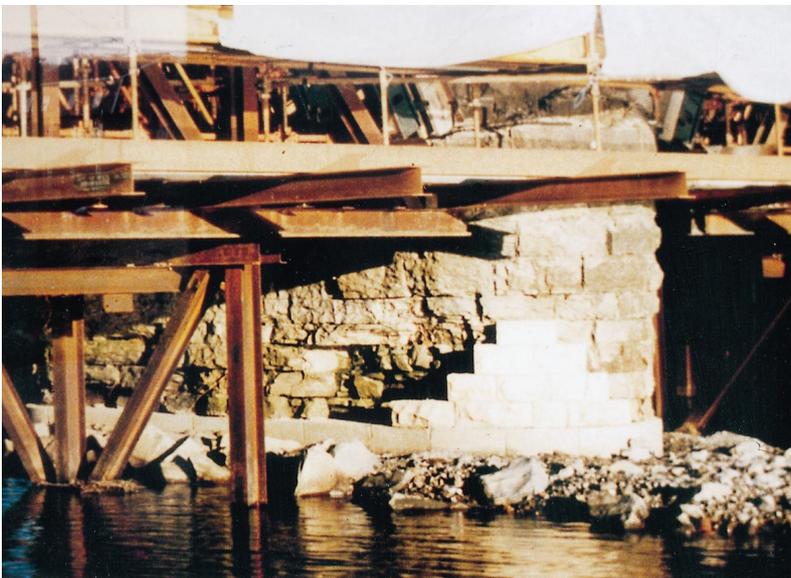
Fig. 20 (above). East pier—piecing in new stone above reinforced concrete collar

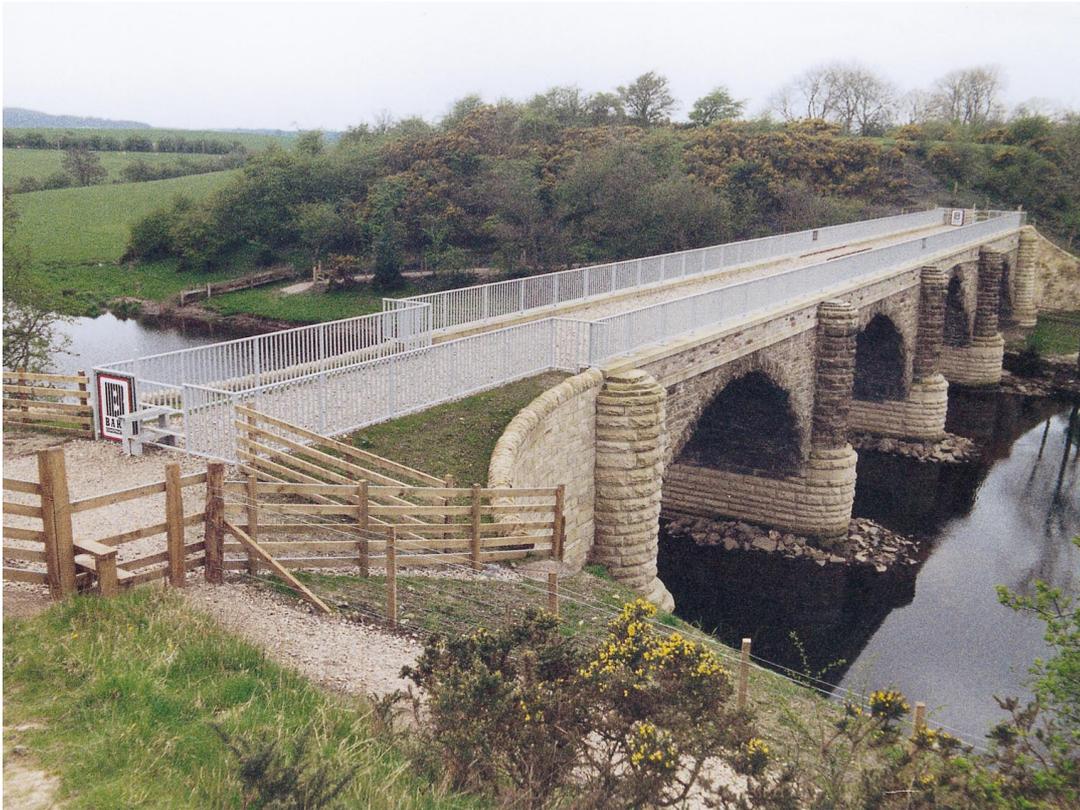
*Fig. 22. North face
with footpath ramps at
each side, fencing and
deck finishings*

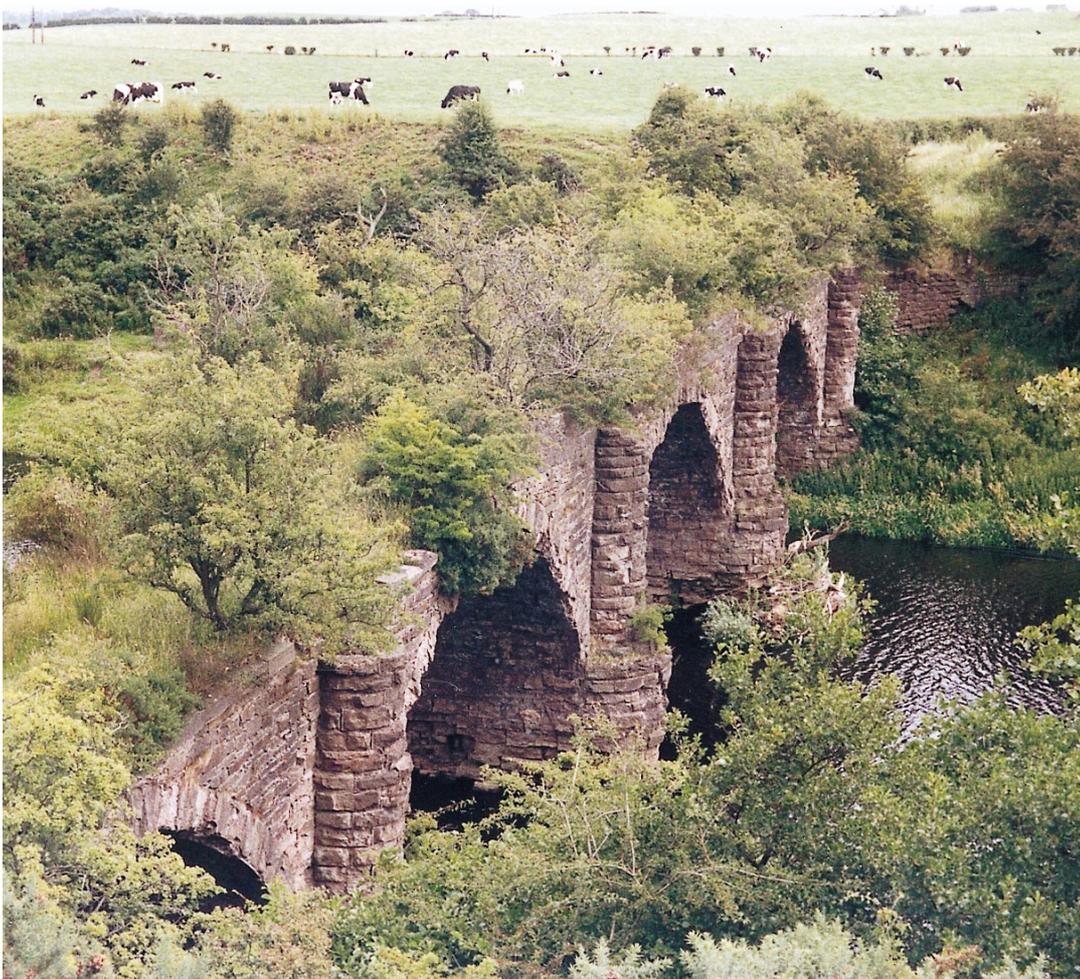
*Fig. 23. South face in
1992*

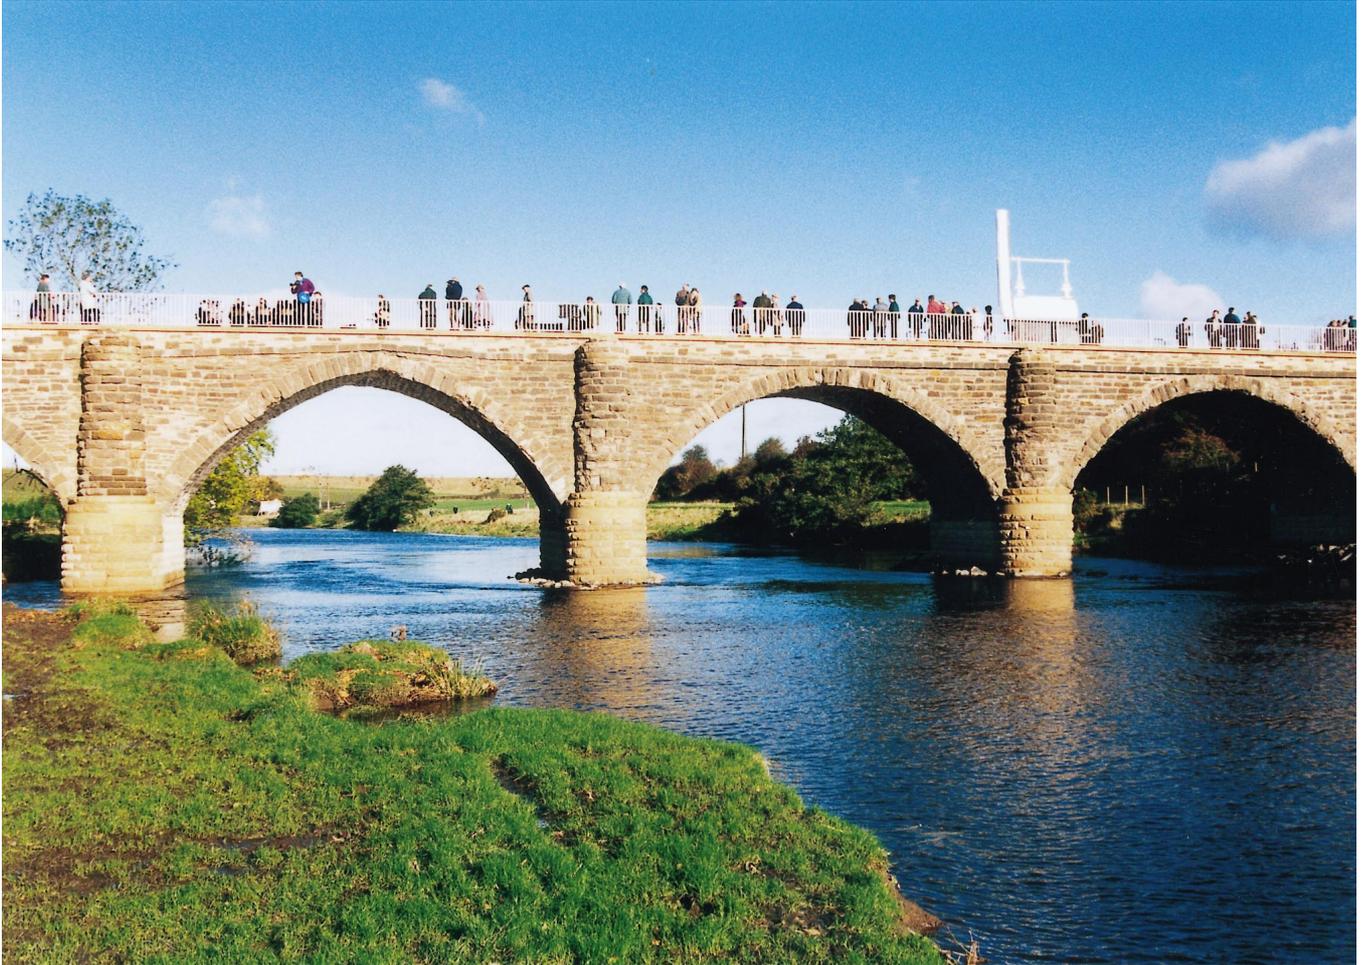
Fig. 24. South face at the re-opening (courtesy Dr M. Oglethorpe)
