## **CAST-IRON CRESTS ON THE BRIDGE FACES OF THE ENGLISH & SCOTTISH PYLONS**

### **DATE OF MANUFACTURE**

1819-1821

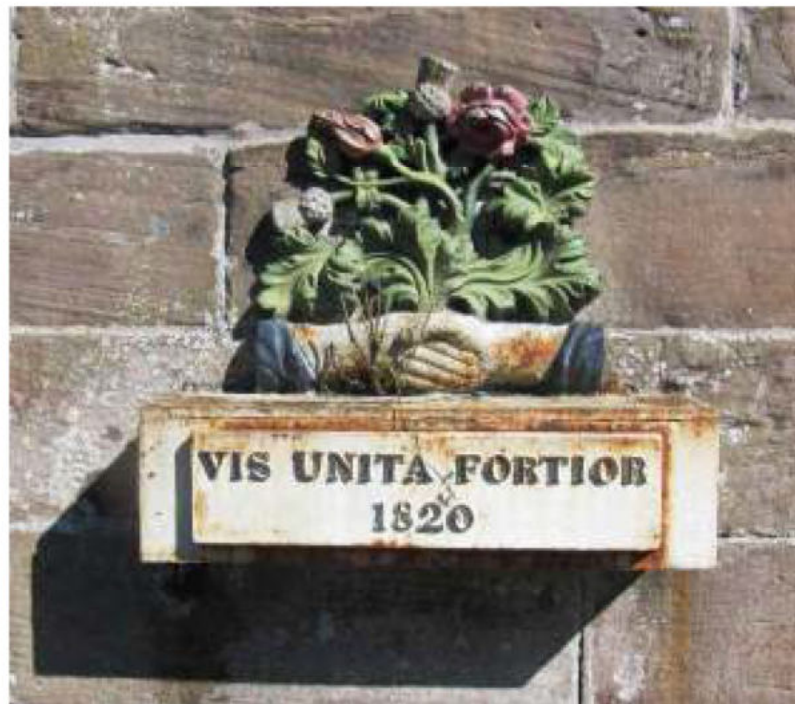
Current location: English Pylon

A two-piece cast-iron box with circular holes in each end, with a moulded cast-iron crest attached to the rear of the top, painted in white, red, dark blue and green, in the form of roses, intertwined with thistles and oak leaves with embraced hands and arms with dark blue sleeves. To the front is welded a cast-iron plate with raised dark blue lettering in Latin, 'VIS UNITA FORTIOR', which roughly translates as '*UNION IS STRENGTH*' dated beneath, '1820'.

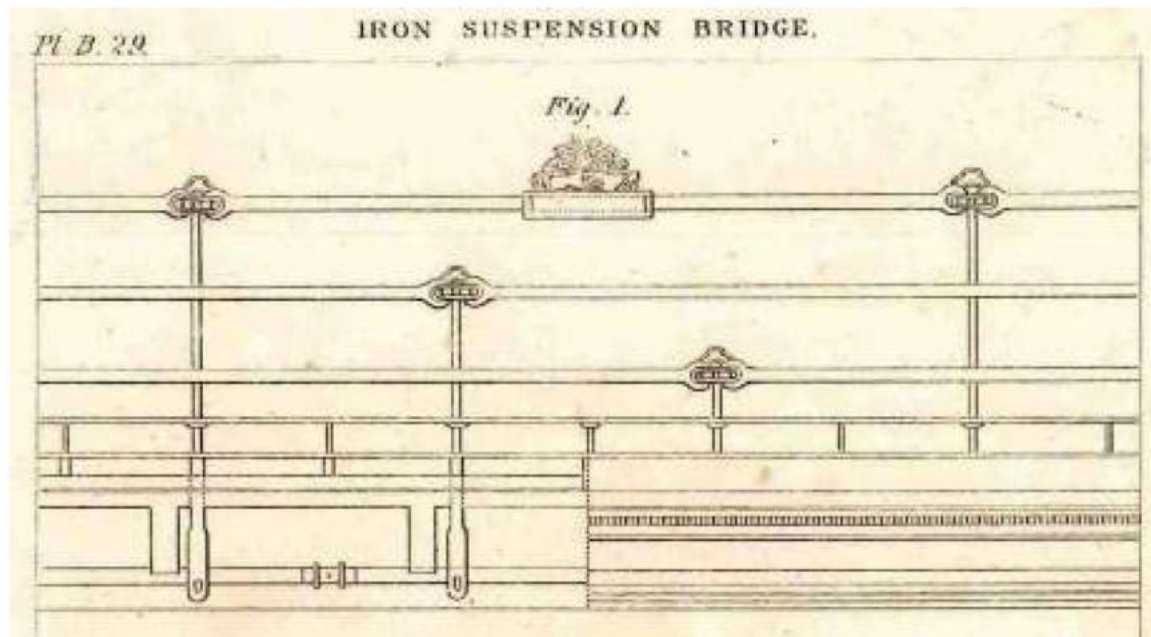
1830 '*A Dictionary of Architecture*', by R. Stuart (Private Collection)

In his '*A Dictionary of Architecture*', published in 1830, R. Stuart includes engravings of Samuel Brown's 1819 designs for the 'Iron Suspension Bridge over the Tweed', with details of the deck, clearly showing a crest attached to the top chain at the mid-point of the bridge – the actual border between England and Scotland.

The 1830 engraving showing the Crests attached to the top of the central chain would account for the hollow box construction in the form of two halves, each with a central semi-circular hole. These would have attached around the chain and then be bolted together to enable them to be removed when painting the chains.

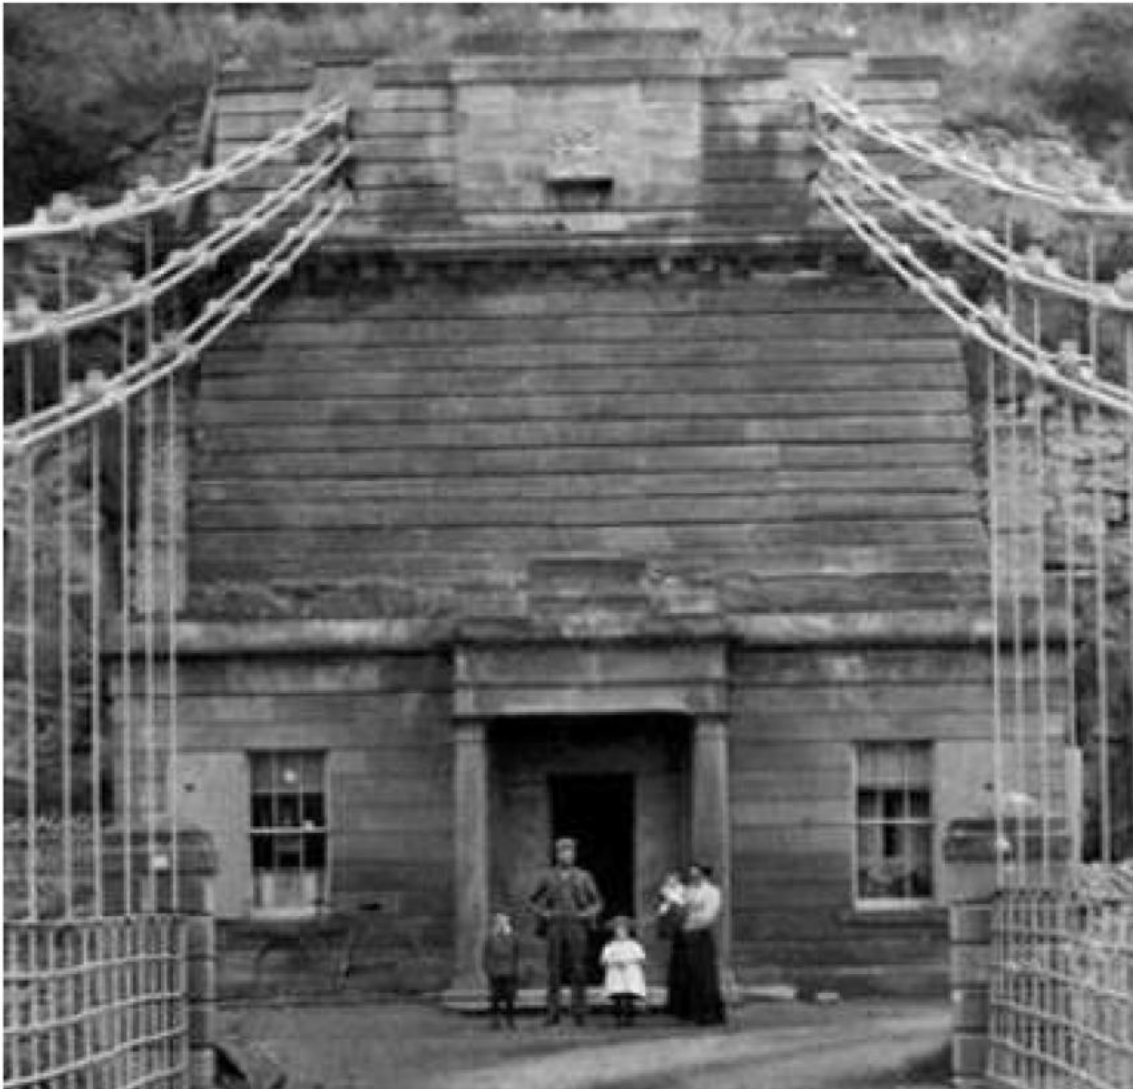
c1890 The Toll House Keeper Mr E. Roxburgh and family [source unknown]

A glass plate photograph of the English Pylon and Cottage, dating from the 1890s, is the first evidence of one of the Crests' current location after removal from the centre of the Bridge.
