## The Sea versus Wick Breakwater 1863-77 – an instructive disaster

**Roland Paxton** Prof Dr, School of the Built Environment Heriot-Watt University  
Vice-chairman ICE Panel for Historical Engineering Works

In this paper the project and its sea damage failure mechanisms are identified from unpublished and other primary sources and reviewed in an historical engineering context. Repeated damage led to the loss of nearly one-third of the length of the breakwater in 1870, with abandonment following destruction of its 2642 t composite replacement end in 1877.

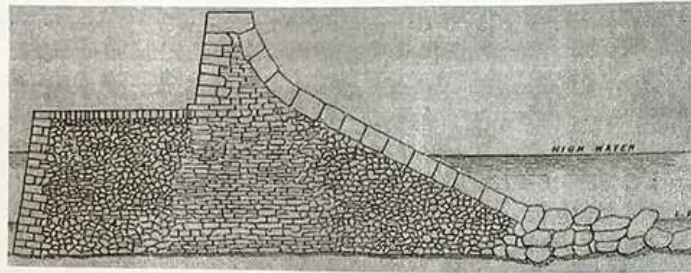
Figure 2. Cross-section of South Pier outer harbour<sup>4</sup>

The outer harbour is protected by Bremner's substantial South Pier 9.8 m high [Figures 2&3] later extended. This pier comprising vertical and inclined coursing and founded just below low water on a wide base has survived many gales, but often suffered damage to the roadway, hearting, and inner wall from water falling from a great height after wave impact.

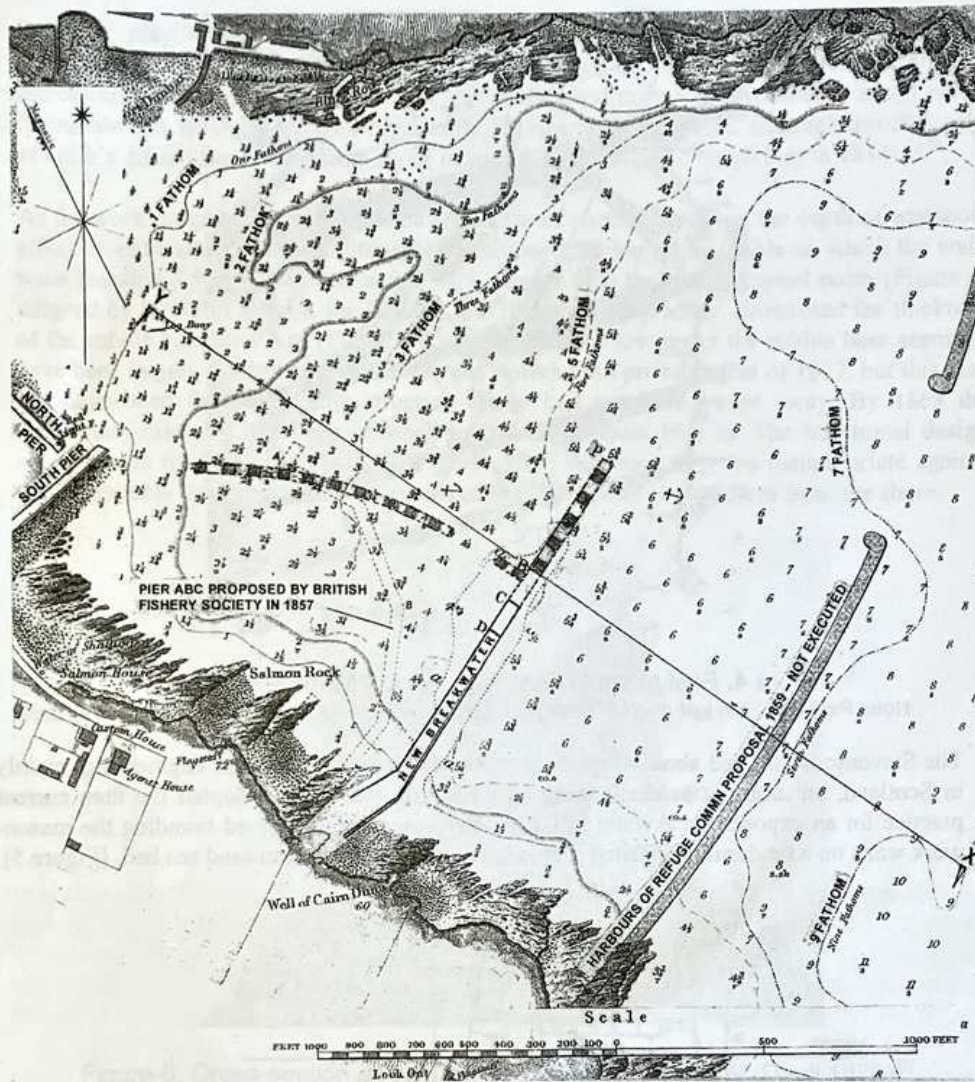
Figure 3. Composite plan of D. & T. Stevenson breakwater as built <sup>5,6,8</sup>

In 1861, a compromise was approved for a third harbour protected by a breakwater 457 m long located between the proposals of the Society and Commission [Figure 3]<sup>5,6,8</sup>. The breakwater was designed for the Society in 1861-2 by leading engineers D. & T. Stevenson of Edinburgh. It was begun in 1863 but had no prospect of completion after a south-easterly storm in February 1870 carried away nearly one-third of its length at the seaward end. Further major damage in 1877 led to abandonment after a total outlay of about £132,000.<sup>9</sup>

1868 Sept	Greatest length of completed breakwater reached - 320 m. <sup>8</sup>
1868 Oct	A 75 m length partly demolished by the sea. Rubble base washed down to 4.6 m below low water. <sup>11</sup>
1870 Feb	Seaward 116 m length destroyed to 1.5 -1.8 m below low water. Waves 12.8 m from crest to hollow during 3-day storm. Materials and workmanship not at fault being throughout of 'superior' quality. <sup>9,10</sup>
1870 Oct	A 55 m length now rebuilt to new composite end - overall length 259 m instead of 480 m planned. <sup>10</sup> Parapet omitted on rebuilt work - stepped end to remainder. Top rebuilt in concrete - full breadth now coursed work. Sea end face vertical. Introduction of large concrete blocks tied by iron bars. <sup>10</sup>
1872 Feb	Storm as severe as in February 1870 - waves 6 m high and 80 m apart with a velocity of 36 kph. <sup>10</sup>
1872 Feb	Face stones shattered by sea - 'unparalleled'. <sup>8</sup> Waves about 9 m high - spray about 60 m high. <sup>12</sup>

1872 Dec	Replacement composite concrete and stone end of 1372 t demolished. Resident Engineer M'Donald saw it 'slewed round by successive strokes until removed and deposited inside pier - foundation 10 feet below low water uninjured'. Followed by destruction of adjoining 46 m length 'of solid structure set in cement'. Water 7.6 - 9.1 m deep passing over parapet + 8 t & 10 t stones. <sup>8,11</sup> [Figures 16-20]
1875 Nov	Breakwater 252 m long (from shore high water mark). <sup>10</sup> [Replaced by heavier concrete end in 1873]
1877 Jan	Sea demolition of 2642 t end - adjoining length destroyed in storms. Project abandoned in August. <sup>13</sup>

- Key:
- A Outer limit to which rubble base formed – dotted line 'a' shows 1870 extent
  - B Greatest length of superstructure actually built [320 m]
  - C End of 1871 reconstruction and 1873 restoration. February 1870 breach point
  - D End of breakwater left standing after 1872 storm destruction [Figure 17]
  - P Length planned in 1862 + inner breakwater (wide broken lines - unexecuted)
  - X-Y Line of longitudinal section along Wick Bay [Figure 20]

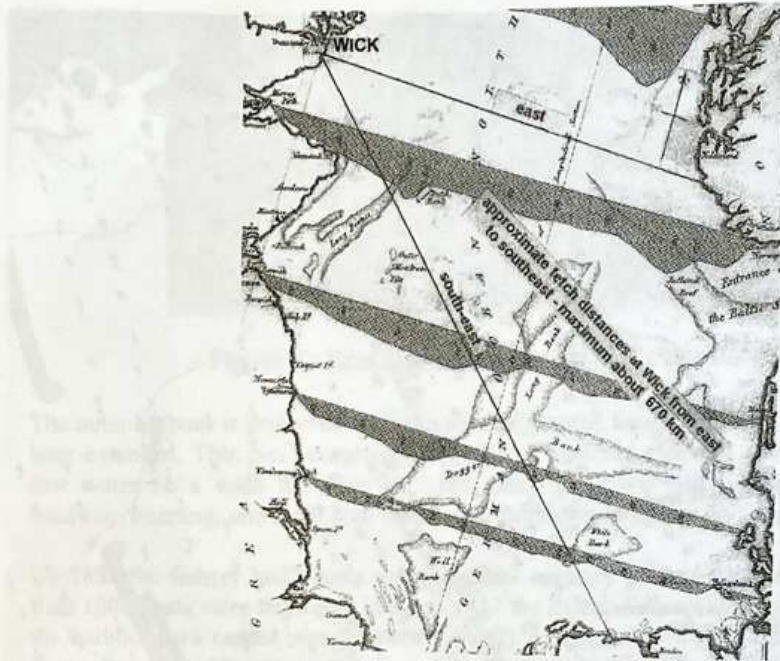
Thomas Stevenson, about to publish his text-book on the design and construction of harbours, was aware that Wick was an exposed site with a fetch of several hundred miles. Applying his soon to be well-known approximation for maximum wave height ( $w$ ) in strong gale conditions =  $1.5 \sqrt{d}$  (the fetch [Figure 4]) he would have expected waves of 7 - 9 m.<sup>4</sup>

Figure 4. East to south-east fetch across North Sea to Wick<sup>14</sup>  
 Note: Pentland Firth just north of Wick with tidal currents of up to about 22 kph each way daily

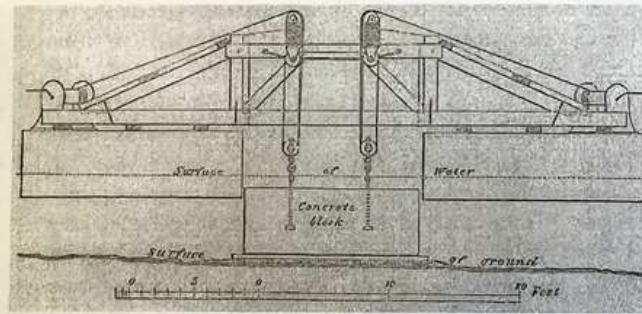
This use of massive pre-cast Portland cement concrete blocks was innovative. Dimensions varied but a large block measured 1.7 x 4.0 x 6.7 m. A mix of 1(cement):7(sand/stone) was used. The blocks were made on 12 platforms 0.6 m above low water and transported to the rubble by a specially made pontoon with corner winches [Figure 14] with final placing by divers. The weight of this block was 1002 kN in air and 544 kN in sea water. This near halving of weight under water was an experience in which trainee engineer R. L. Stevenson revelled when diving. He also noted a block being accidentally lowered on to a diver's foot!<sup>1</sup>

Figure 14. Lowering concrete block from pontoon [Stevenson]<sup>8</sup>
