The Sea versus Wick Breakwater 1863-77 – an instructive disaster

Roland Paxton Prof Dr, School of the Built Environment Heriot-Watt University
Vice-chairman ICE Panel for Historical Engineering Works

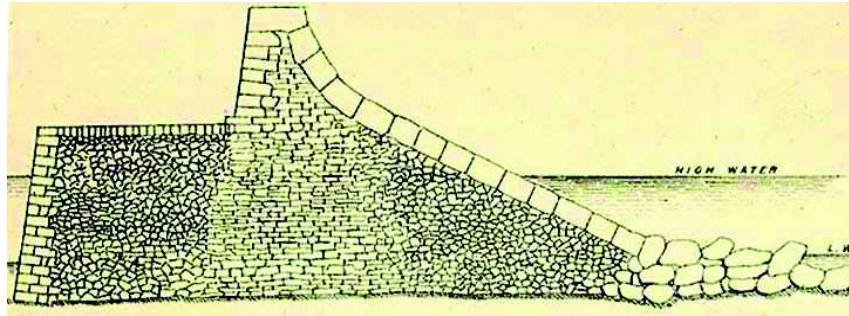
Figure 2. Cross-section of South Pier outer harbour⁴

The outer harbour is protected by Bremner's substantial South Pier 9.8 m high [Figures 2&3] later extended. This pier comprising vertical and inclined coursing and founded just below low water on a wide base has survived many gales, but often suffered damage to the roadway, hearting, and inner wall from water falling from a great height after wave impact.

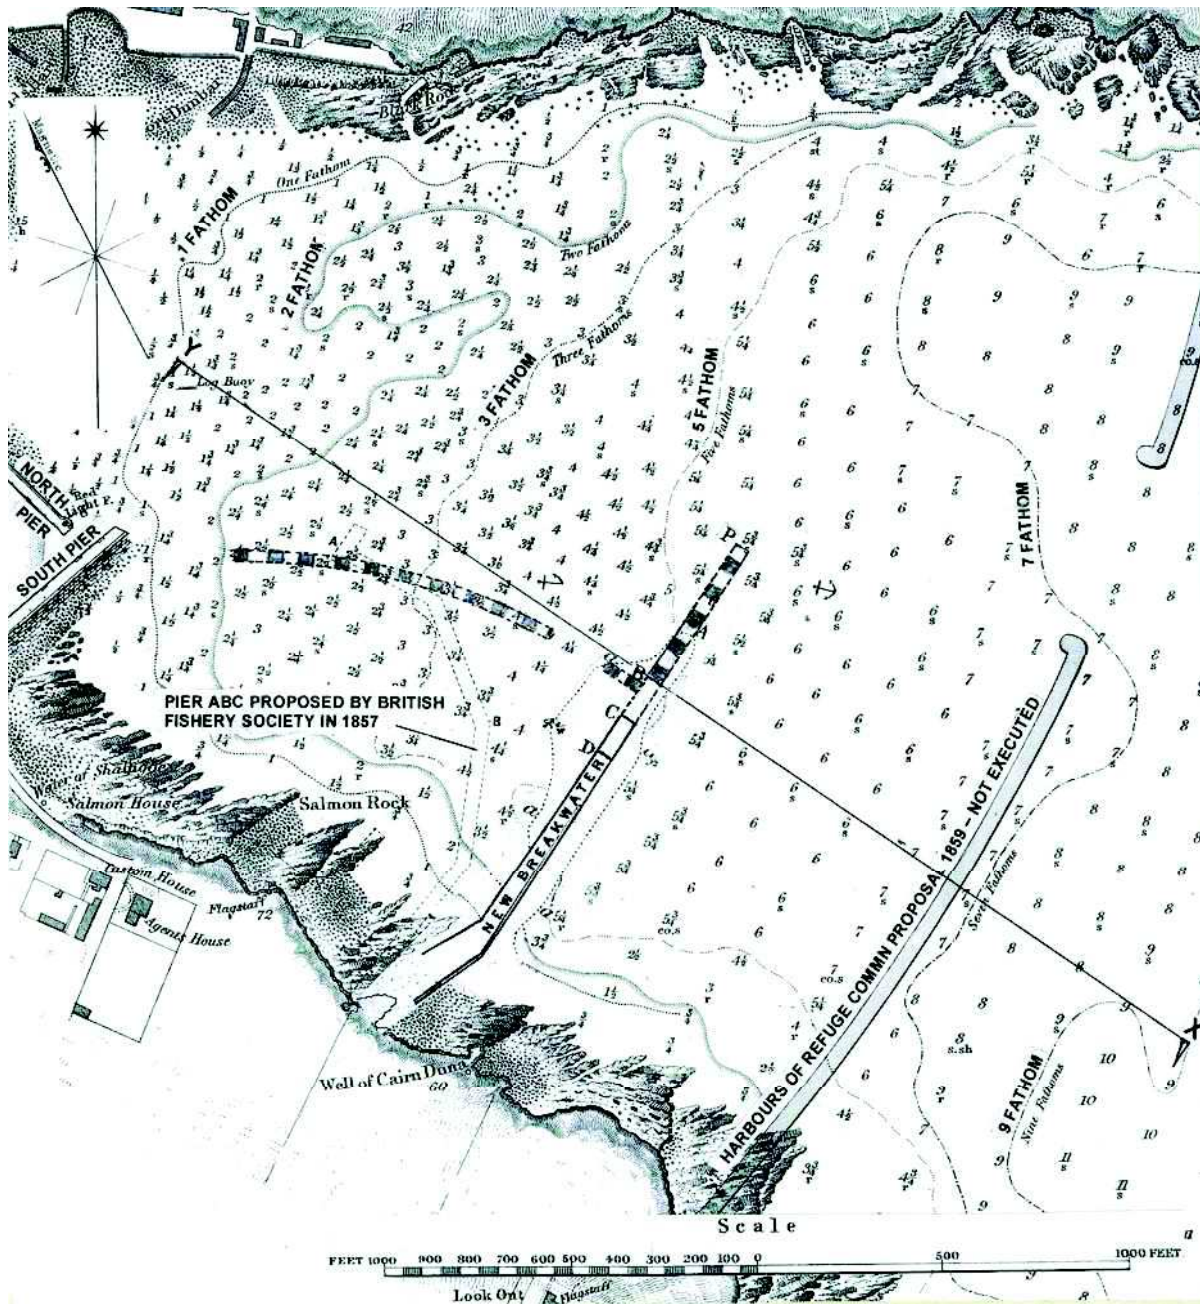
Figure 3. Composite plan of D. & T. Stevenson breakwater as built ^{5,6,8}

In 1861, a compromise was approved for a third harbour protected by a breakwater 457 m long located between the proposals of the Society and Commission [Figure 3]^{5,6,8}. The breakwater was designed for the Society in 1861-2 by leading engineers D. & T. Stevenson of Edinburgh. It was begun in 1863 but had no prospect of completion after a south-easterly storm in February 1870 carried away nearly one-third of its length at the seaward end. Further major damage in 1877 led to abandonment after a total outlay of about £132,000.⁹

- Key: A Outer limit to which rubble base formed – dotted line ‘a’ shows 1870 extent
- B Greatest length of superstructure actually built [320 m]
- C End of 1870-72 reconstruction and 1873 restoration
- D End of breakwater left standing after 1872 storm destruction [Figure 17]
- P Length planned in 1862 + inner breakwater (wide broken lines - unexecuted)
- X-Y Line of longitudinal section along Wick Bay [Figure 20]

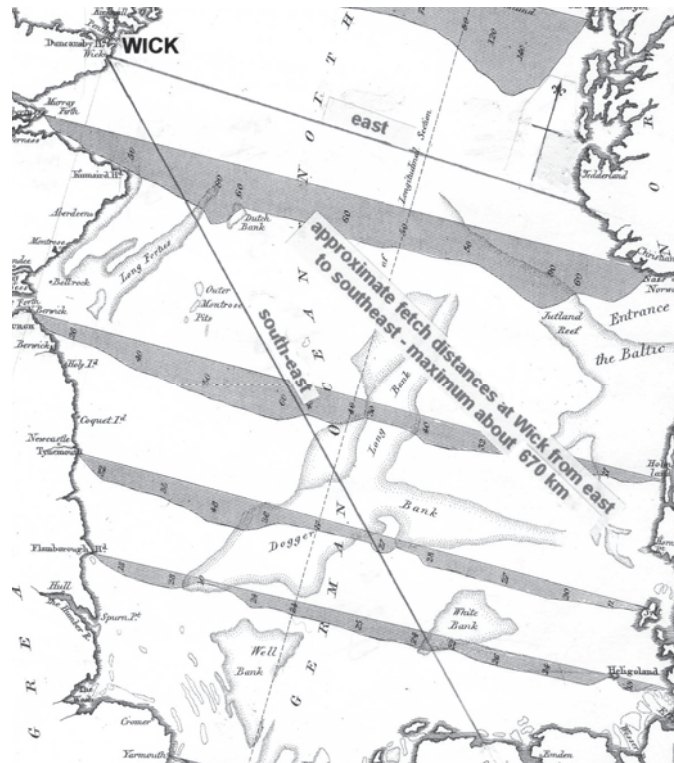
Figure 4. East to south-east fetch across North Sea to Wick¹⁴

Thomas Stevenson, about to publish his text-book on the design and construction of harbours, was aware that Wick was an exposed site with a fetch of several hundred miles. Applying his soon to be well-known approximation for maximum wave height (w) in strong gale conditions = $1.5 \sqrt{d}$ (the fetch [Figure 4]) he would have expected waves of 7 - 9 m.⁴

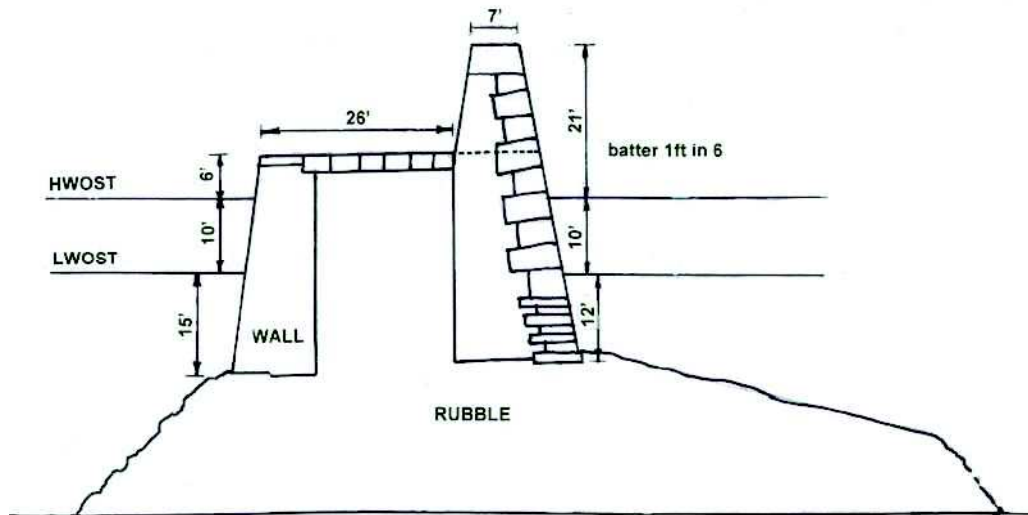
Figure 5. Design cross-section 268 m from shore (1862)⁶
 NB Tidal range (m) 1984-9: HAT 0.0; MLWS +0.7; MLWN +1.4; MSL +2.0; MHWN +2.8; MHWS +3.5⁷

As the work progressed out into the bay, because of uncertainty about the depth of any scour effect of wave action, D. & T. Stevenson positioned the top of the rubble on which the walls were founded 5.5 m below low water, 50% deeper than the then accepted norm [Figure 5] adopted by Sir John Rennie, the Rendels and others.⁸ This practice diminished the thickness of the rubble base to 3.7 m [Figure 6]. At 5.5 m below low water the rubble base seems to have been largely undisturbed by the various storms until probably that of 1877, but this may not have been the case if the structure above had not been swept away. By 1868 the breakwater masonry had been widened by 1.7 m to about 16.3 m. The traditional design adopted with its 4.6 m high parapet [Figures 5&6] was soon to prove inappropriate against the exceptional sea conditions it encountered beyond a point about 150 m from the shore.

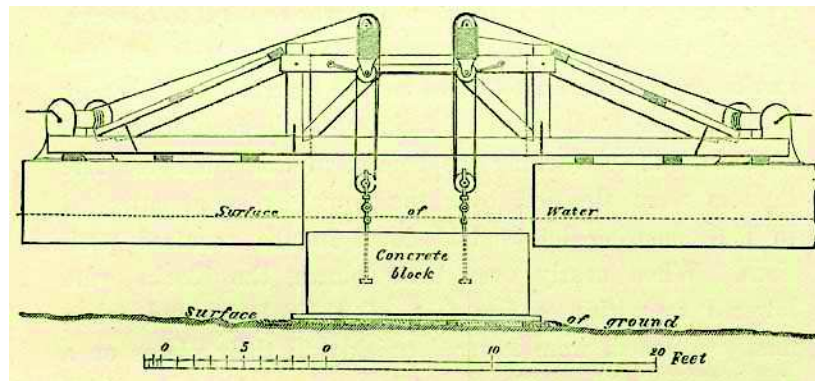
Figure 14. Lowering concrete block from pontoon [Stevenson]⁸

This use of massive pre-cast Portland cement concrete blocks was innovative. Dimensions varied but a large block measured 1.7 x 4.0 x 6.7 m. A mix of 1(cement):7(sand/stone) was used. The blocks were made on 12 platforms 0.6 m above low water and transported to the rubble by a specially made pontoon with corner winches [Figure 14] with final placing by divers. The weight of this block was 1002 kN in air and 544 kN in sea water. This near halving of weight under water was an experience in which trainee engineer R. L. Stevenson revelled when diving. He also noted a block being accidentally lowered on to a diver's foot!¹
