Conservation of the 1811 Railway Viaduct at Laigh Milton, Scotland*

by Roland Paxton**

Laigh Milton Viaduct over the River Irvine three miles west of Kilmarnock was the major structure on the first public railway in Scotland, the 'Kilmarnock & Troon', which was engineered for horse traction and operated from 1811-46. The four-span viaduct, designed under the direction of eminent engineer William Jessop (1745-1814) and believed to be the world's oldest surviving example of its type, is class A listed by Historic Scotland. From 1988, after nearly 150 years of neglect, the structure was twice reported by structural engineers to be in imminent danger of collapse. In February 1992, with a view to obviating this unwelcome probability, a Conservation Project was initiated by the ICE Panel for Historical Engineering Works with essential support from others and subsequently raised the necessary £1.06m for the viaduct's refurbishment. Work started last June and is due for completion by November 1996.

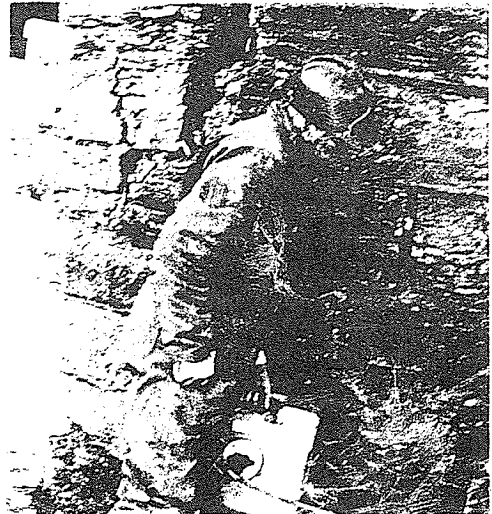
Fig. 17 Pier 1, - radar scanning, with oyo receiver.

At the time of tendering it was essential to minimise uncertainty by providing as much information as possible on the depth, materials and form of the viaduct's foundations. In view of the lack of contemporary information and because it was not practicable for safety reasons to take boreholes at the structure, the author initiated and let a radar scanning site investigation contract to Geospace consultancy Services Ltd for £1.5k. Basically their findings were that the piers were founded above hard material at a depth of 2-3m and that there were fissuring problems in the base of pier 1. In order to furnish more detailed information for pier 1, before Barr Limited finalised their design, further radar scanning was carried out by Dr Colin Stove and the author as a research exercise (Fig 17). Part of this operation was to scan vertically
